Clark Fork River — Smurfit-Stone Site

Hydraulic Modeling, Flood Mapping and Breach Analysis Report

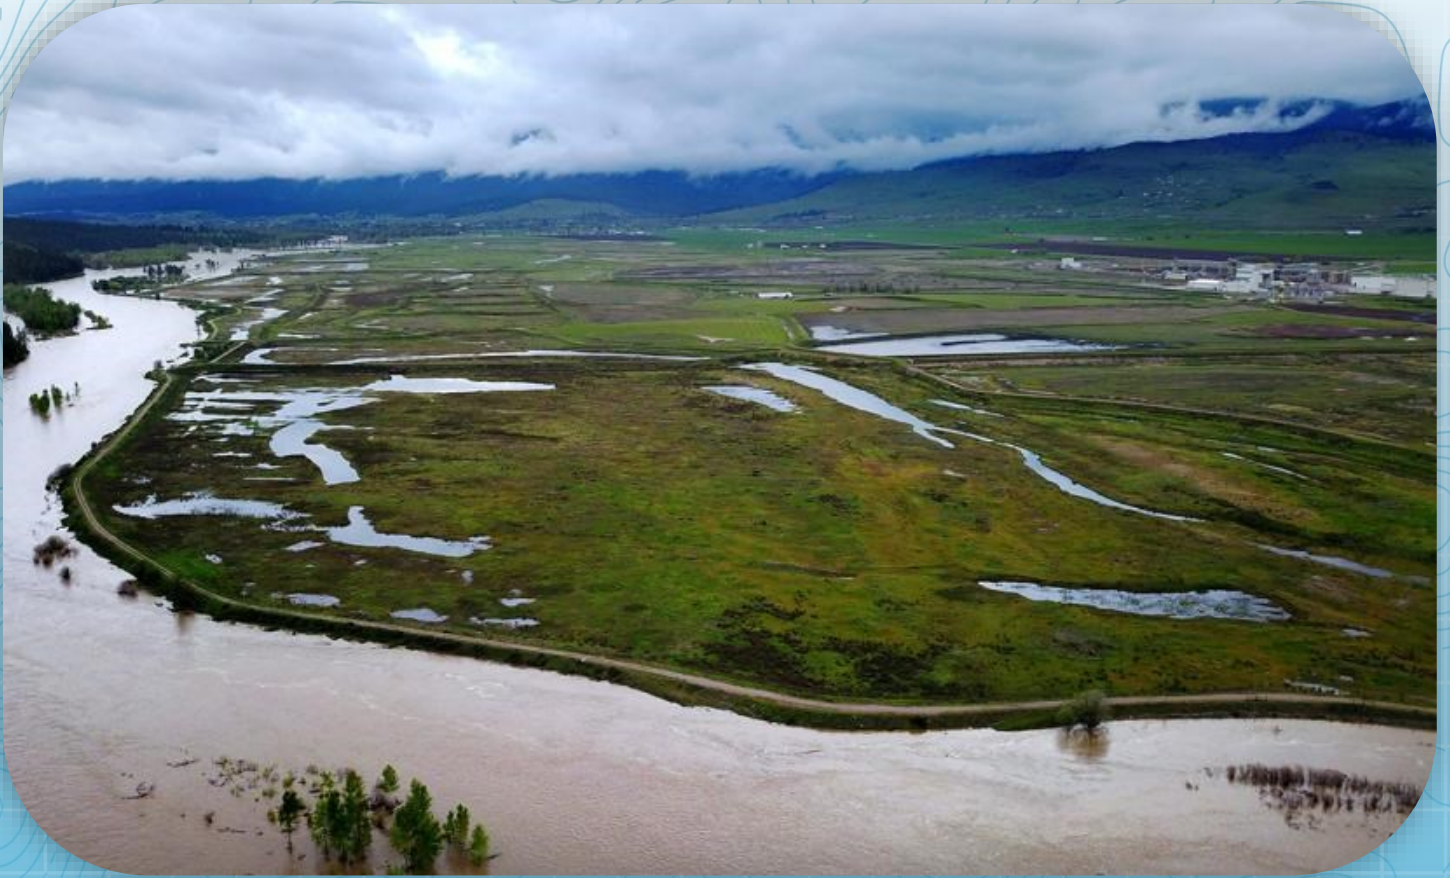
Aerial Photo of Clark Fork River near upstream end of Smurfit-Stone Mill site during 2018 flood.

It is undisputed that the berm is vulnerable to flood risks even under moderate high-flow conditions. For example, high flows on the Clark Fork River in 2018 resulted in a failure of a portion of the berm and a release of contaminants that necessitated an emergency repair by the Army Corps of Engineers. A 2021 study prepared for the Missoula County Health Department mapped the Channel Migration Zone (“CMZ”) through the Smurfit-Stone site and identified several significant risks, including surface erosion, piping, and seepage.¹ This study also identified key areas of risk where confinement of the CMZ results in high-velocity flows against the berm, which multiply the risks of potential failure.

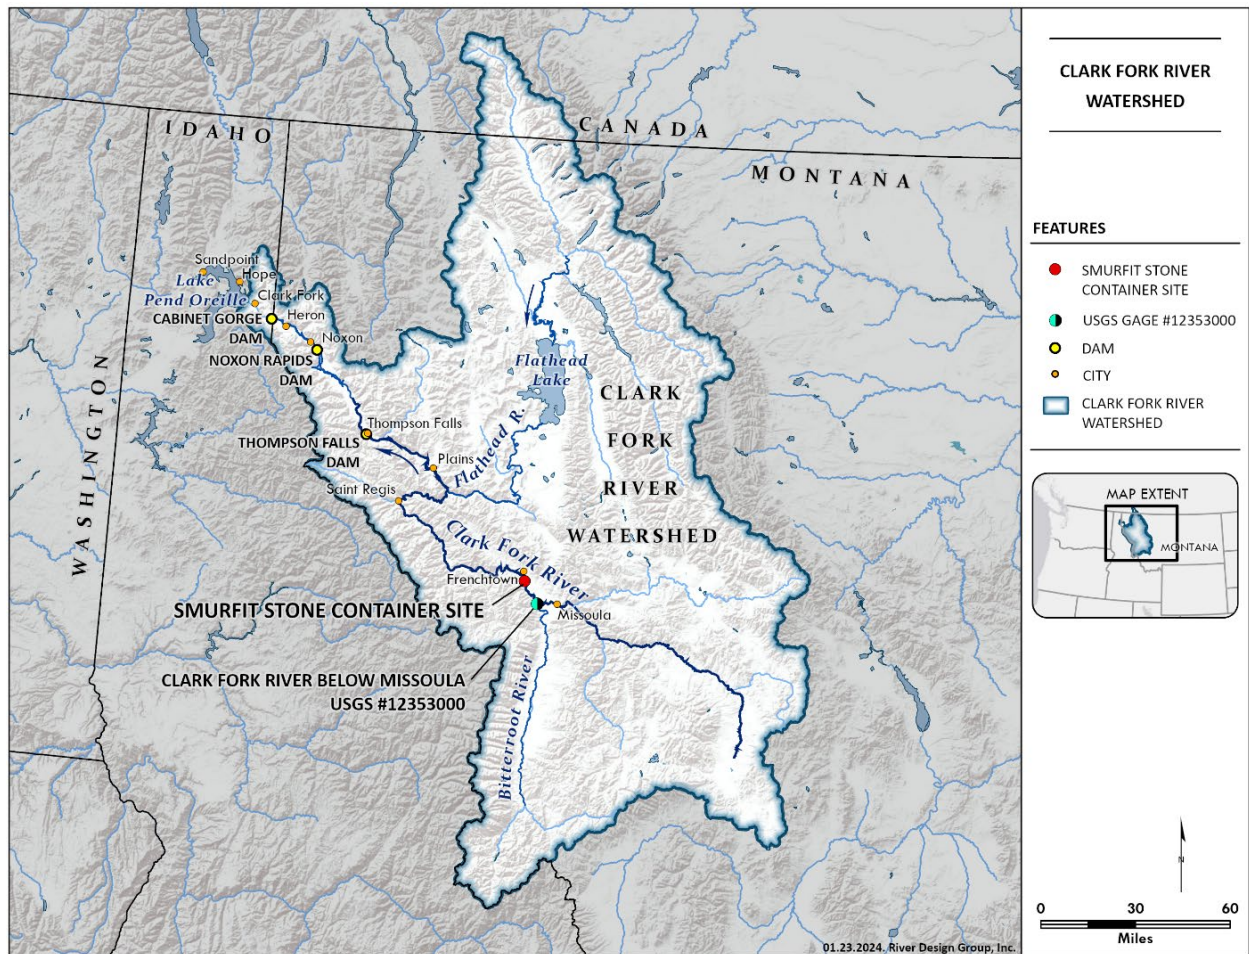
Figure 2-1. Study Reach watershed and gage map.

The headwaters of the CFR originate in Silver Bow Creek and Anaconda Creek. The CFR joins the Bitterroot River just downstream of Missoula (Figure 2-1).

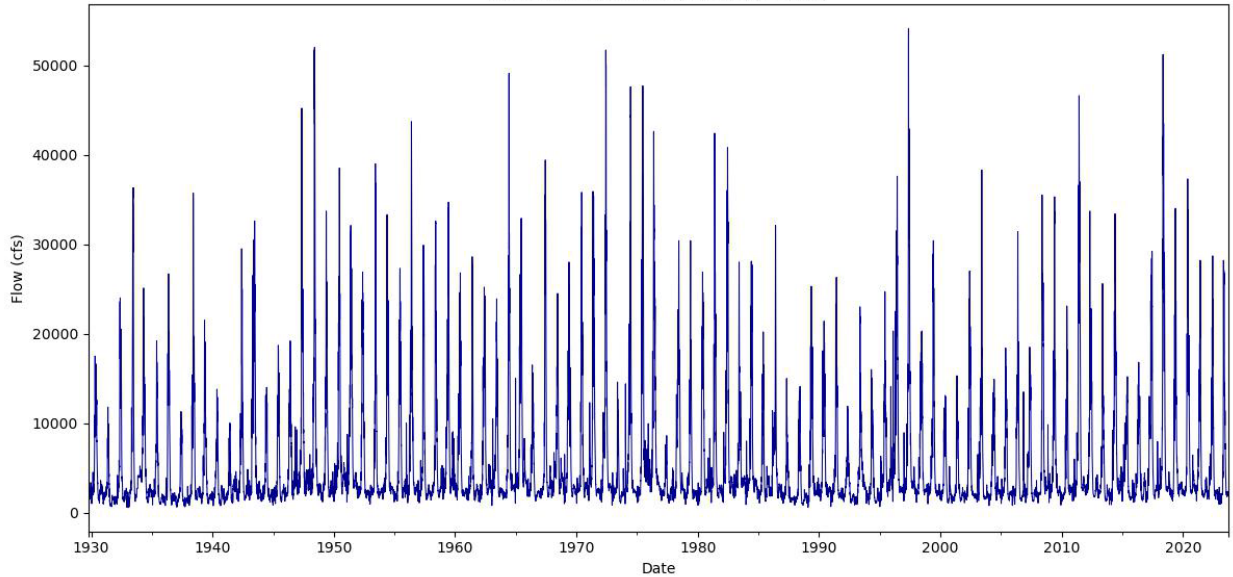
Figure 2-2. Hydrograph of CFR mean daily flows from 1927 through 2023.

The USGS has maintained a streamflow gaging station on the CFR downstream of Missoula (USGS 12353000) since 1929. This gage is located approximately one mile upstream of the Site and is the primary source of data used for the historical flood frequency analysis. Hydrographs of mean daily flows are presented in Figures 2-2 and 2-3.

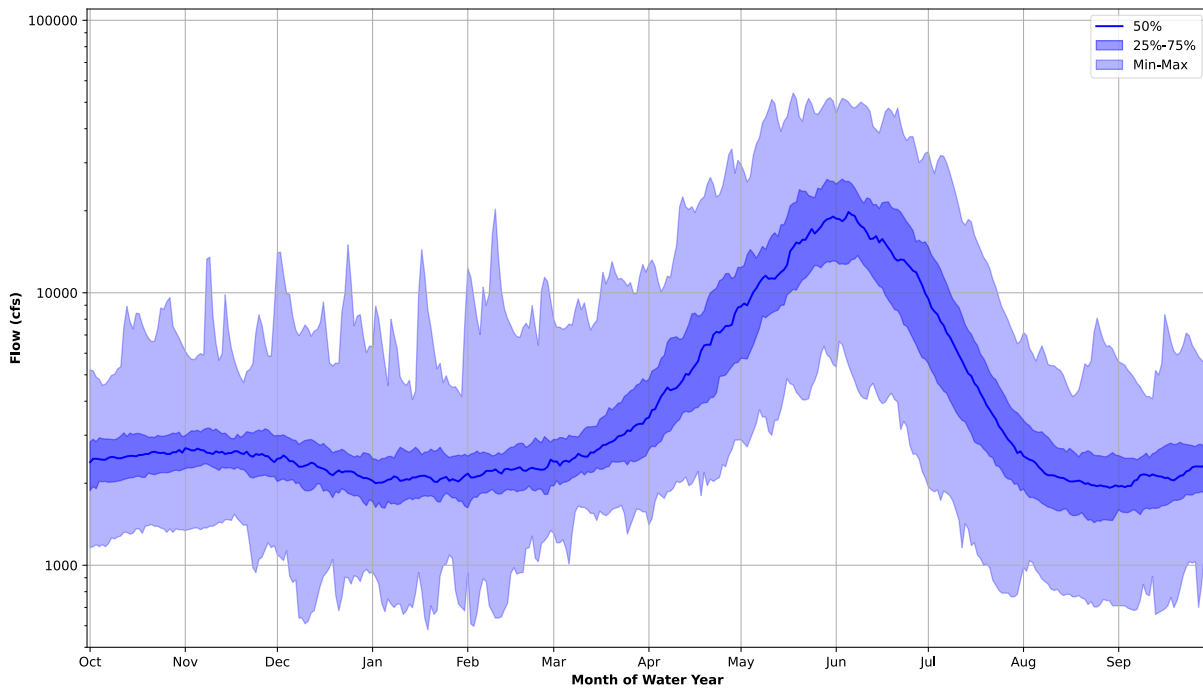
Figure 2-3. Summary hydrograph of CFR mean daily flows from 1927 through 2023.

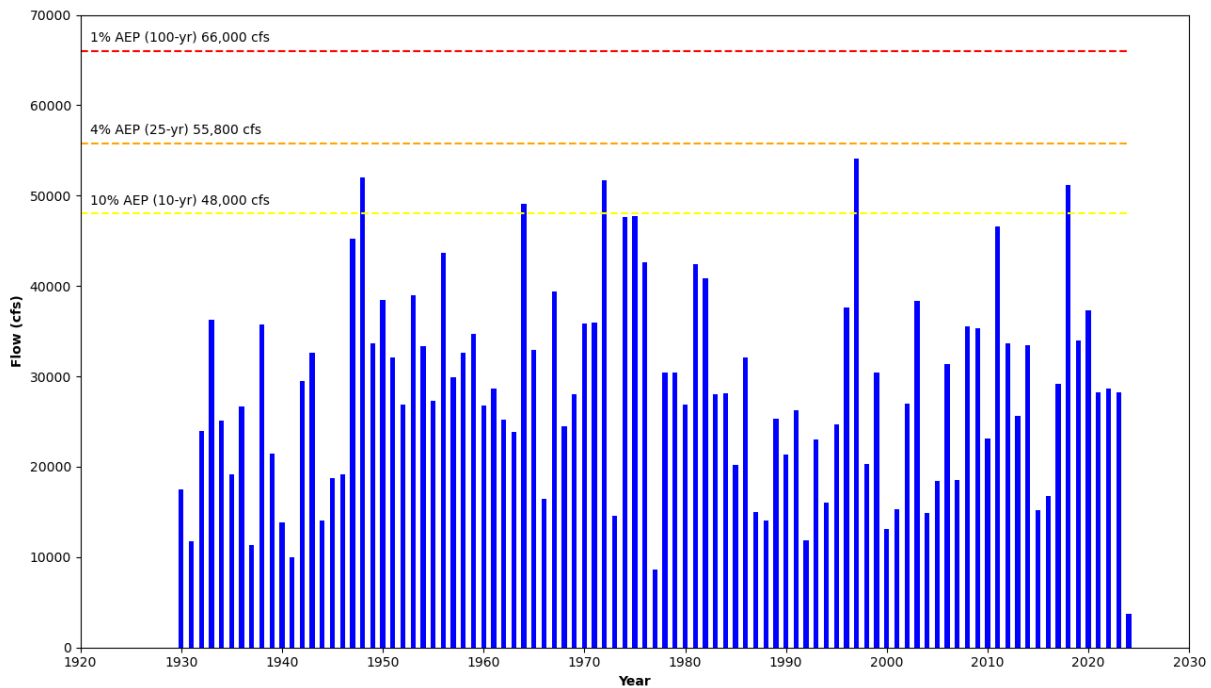
Figure 2-4. Summary hydrograph of CFR mean daily flows from 1927 through 2023.

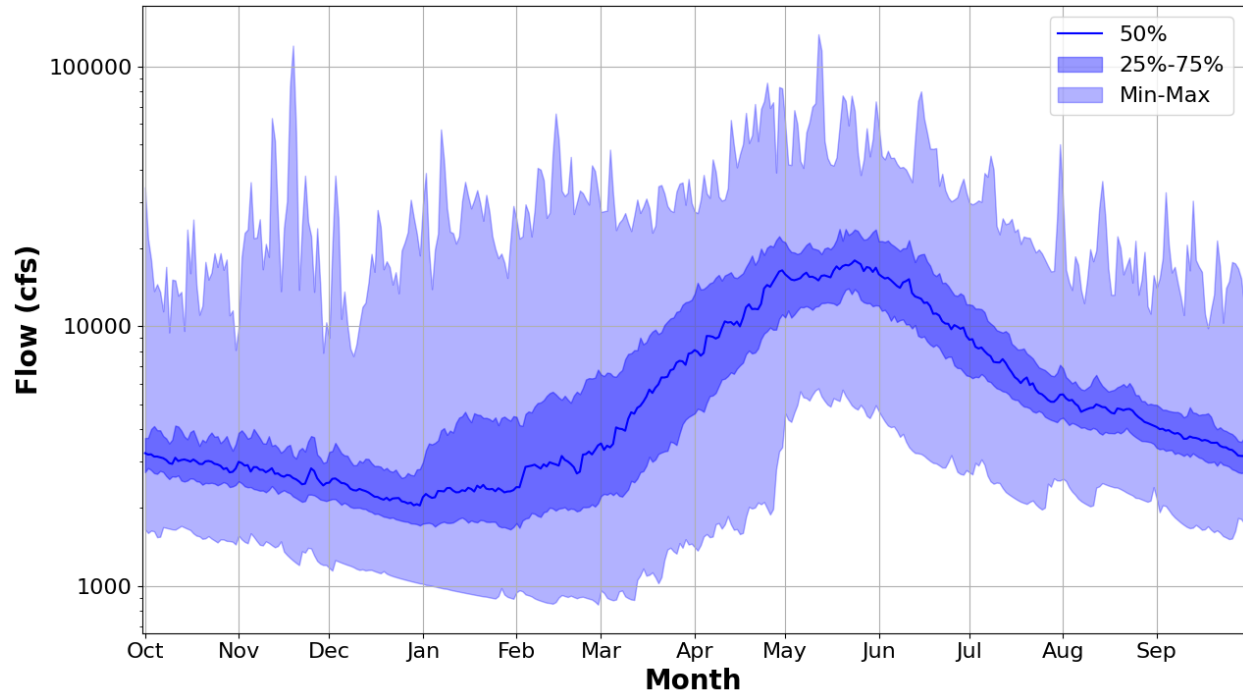
Figure 2-5. Summary hydrograph that exemplifies potential future flows under RCP 8.5.

A total of 160 datasets representing streamflow resulting from two future climate scenarios were developed for the CFR below Missoula. A summary hydrograph for one of the datasets that exemplifies potential future flows is presented in Figure 2-4.

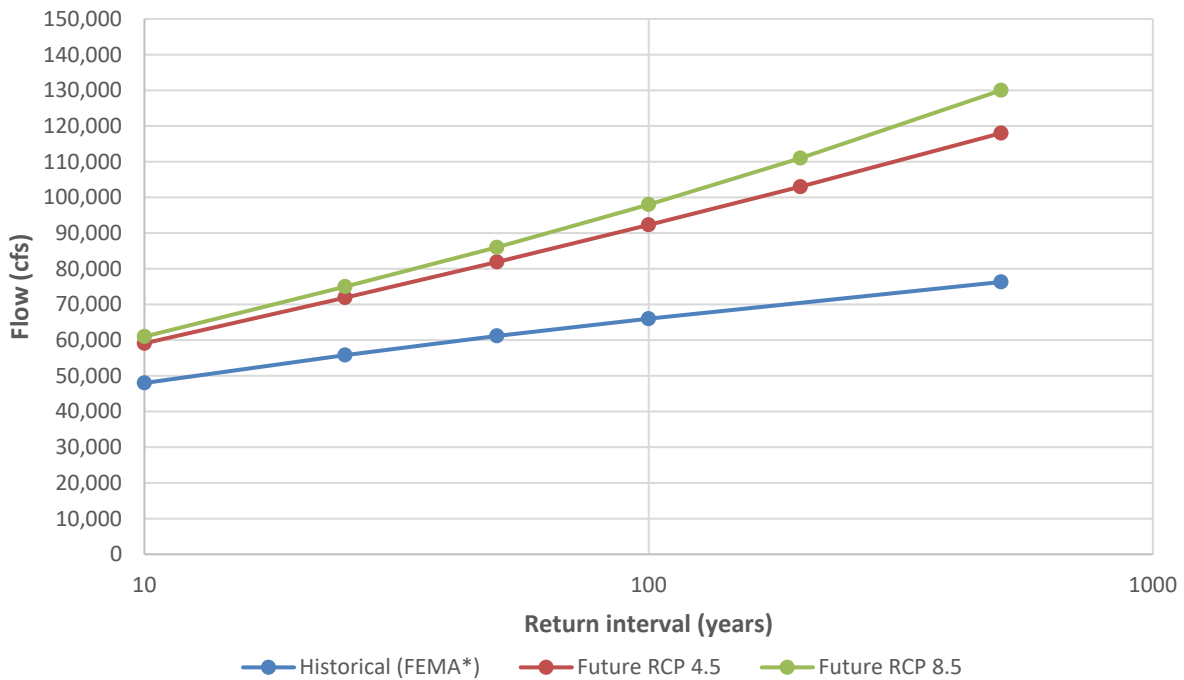
Figure 2-6. Comparison of flood quantiles for historical and future flows.

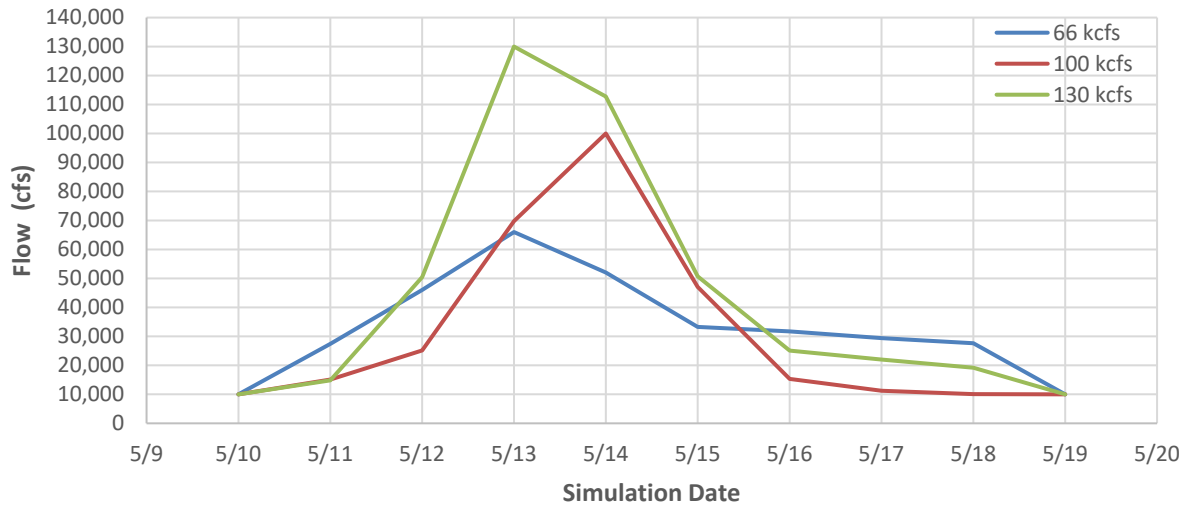
Figure 2-7. Synthetic flow hydrographs for historical and future flows.

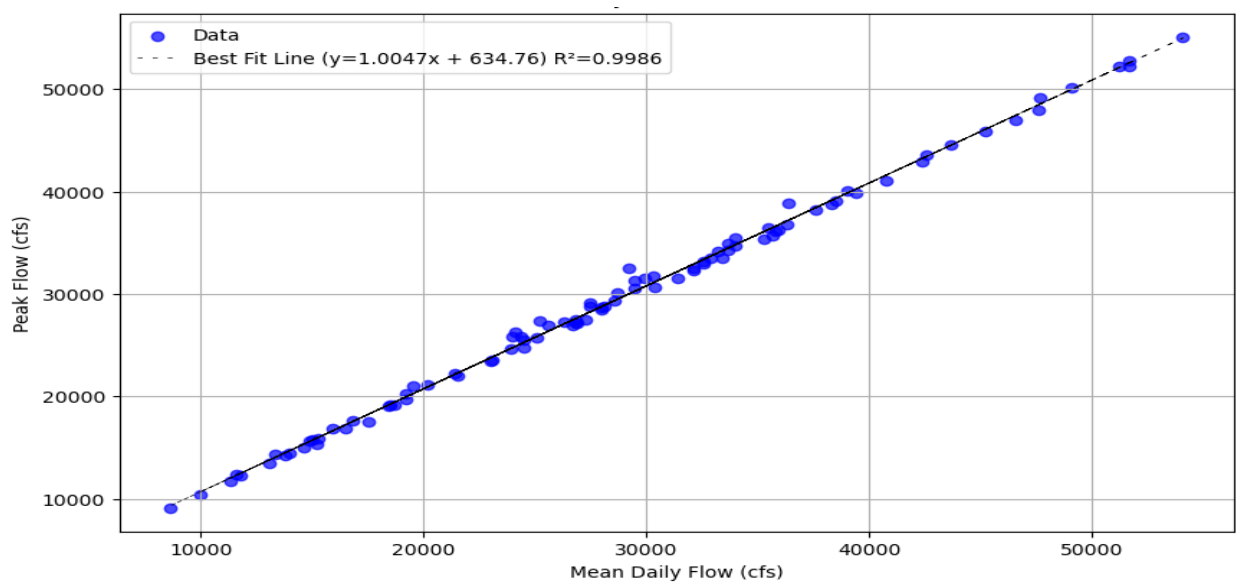
Figure 2-8. Comparison of daily flows with peak flows.

Estimates of peak flow quantiles contain some level of error due to several factors. Measured peak flow values reported by USGS typically have an uncertainty range of 5% to 10%. Uncertainties in modeled future flows include uncertainty inherent in the choice of climate forcing scenario, global circulation model, downscaling method, and hydrologic routing model. Uncertainty estimates for Bulletin 17c flood frequency analyses are reported in terms of confidence limits for historical flood quantiles in Appendix B with differences between upper and lower confidence limits for the historical 100-year flow of +17% and -10% respectively. Differences between instantaneous peak flows and mean daily flows estimated using historical flow data are relatively small at about 2% (Figure 2-7).

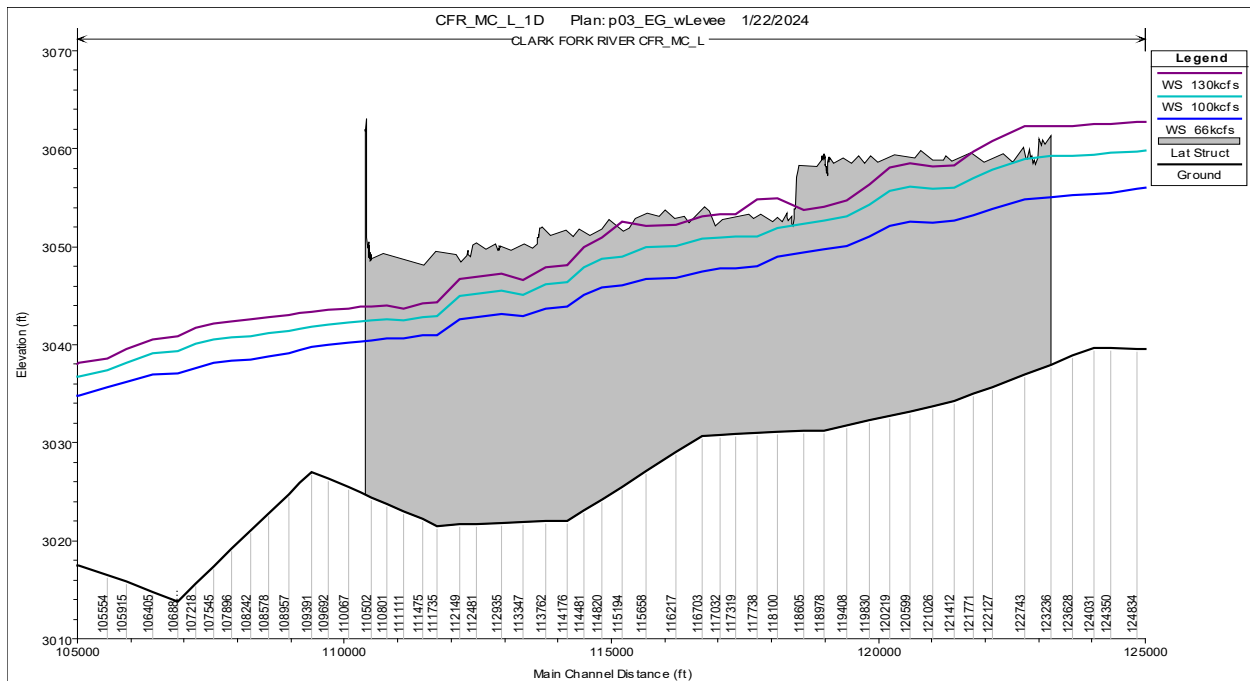
Figure 3-1. Modeled water surface elevations and berm profile.

Water surface elevations were compared with berm elevations to determine potential for overtopping during the three flood events modeled (Figure 3-1). Results for the future 1% AEP (100-year) flow of ~100,000 cfs show limited overtopping of the berms near the upstream end of the Site. The future 0.2% AEP (500-year) flow of ~130,000 cfs results in extensive overtopping of the berms and inundation of the Site.

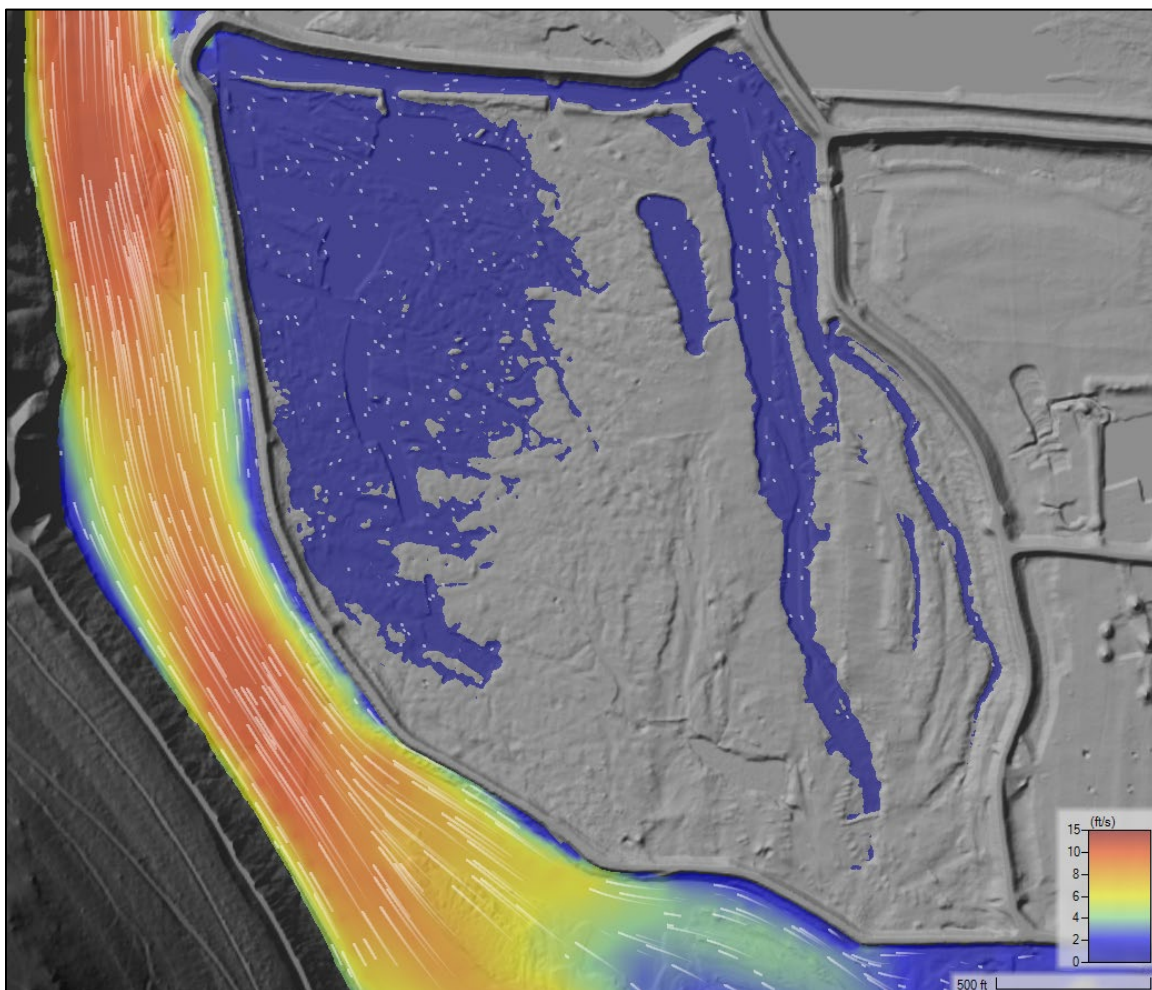
Figure 4-1. Plot of modeled velocities and particle traces for the Scenario 1 piping failure near the north end of Holding Pond 2.

Berm failure modeling indicates that there is potential for potential for berm failure under all three scenarios modeled. Results for Scenario 1, the piping failure at the historical 1% AEP (100-year) flow of 66,000 cfs, show that a piping failure could lead to partial inundation of Holding Pond 2 as shown in Figure 4-1. Flows through the breach approach 200 cfs with maximum

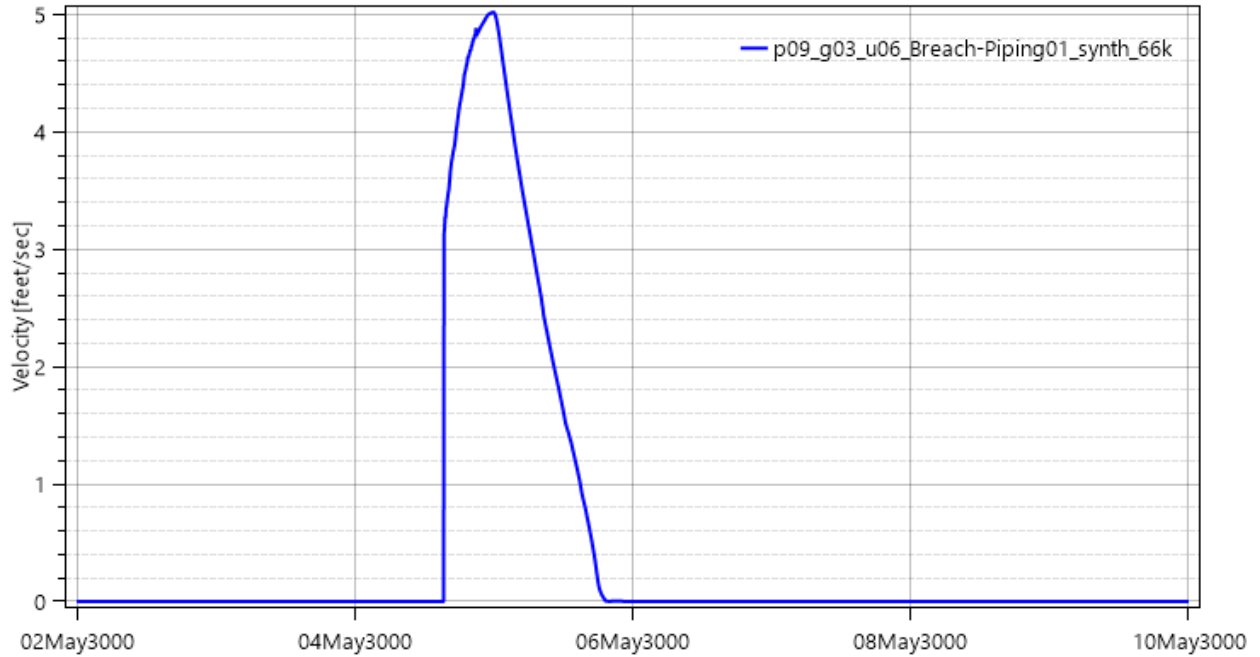
Figure 4-2. Plot of modeled velocities inside of berm at failure point for the Scenario 1 piping failure near the north end of Holding Pond 2.

velocities through the breach of 5 ft/sec (Figure 4-2). The piping failure model output is captured as a video clip (https://youtu.be/tmd_WWlucRg).

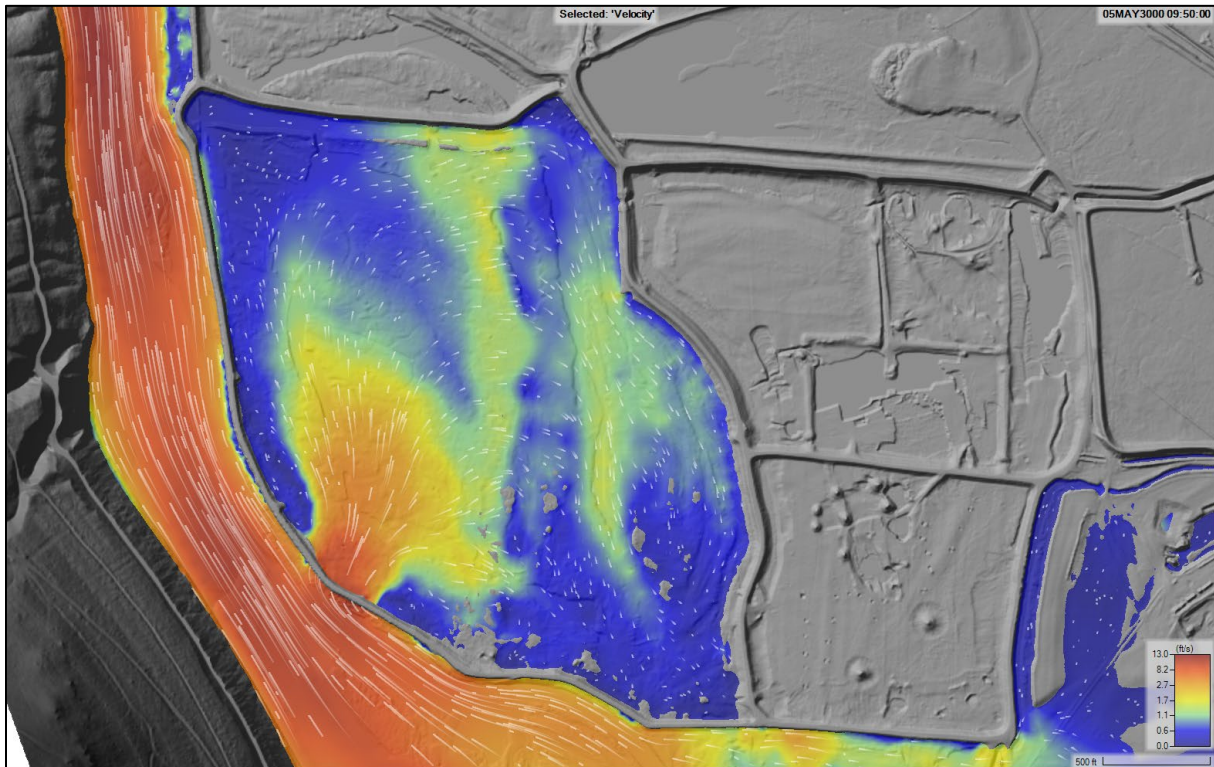
Figure 4-3. Plot of modeled velocities and particle traces at the peak of the Scenario 2 mass-wasting failure near the southeast end of Holding Pond 2.

Results for Scenario 2, the mass wasting failure at the future 1% AEP (100-year) flow of ~100,000 cfs, show that a mass wasting failure could lead to complete inundation of Holding Pond 2 as shown in Figure 4-3. Water also flows across the interior berm into Holding Pond 1 in this scenario (Figure 4-4). Flows through the breach exceed 10,000 cfs with maximum velocities through the breach of 5 ft/sec (Figure 4-5). The mass wasting failure model output is captured as a video clip (<https://youtu.be/lZU9RnB88ws>).

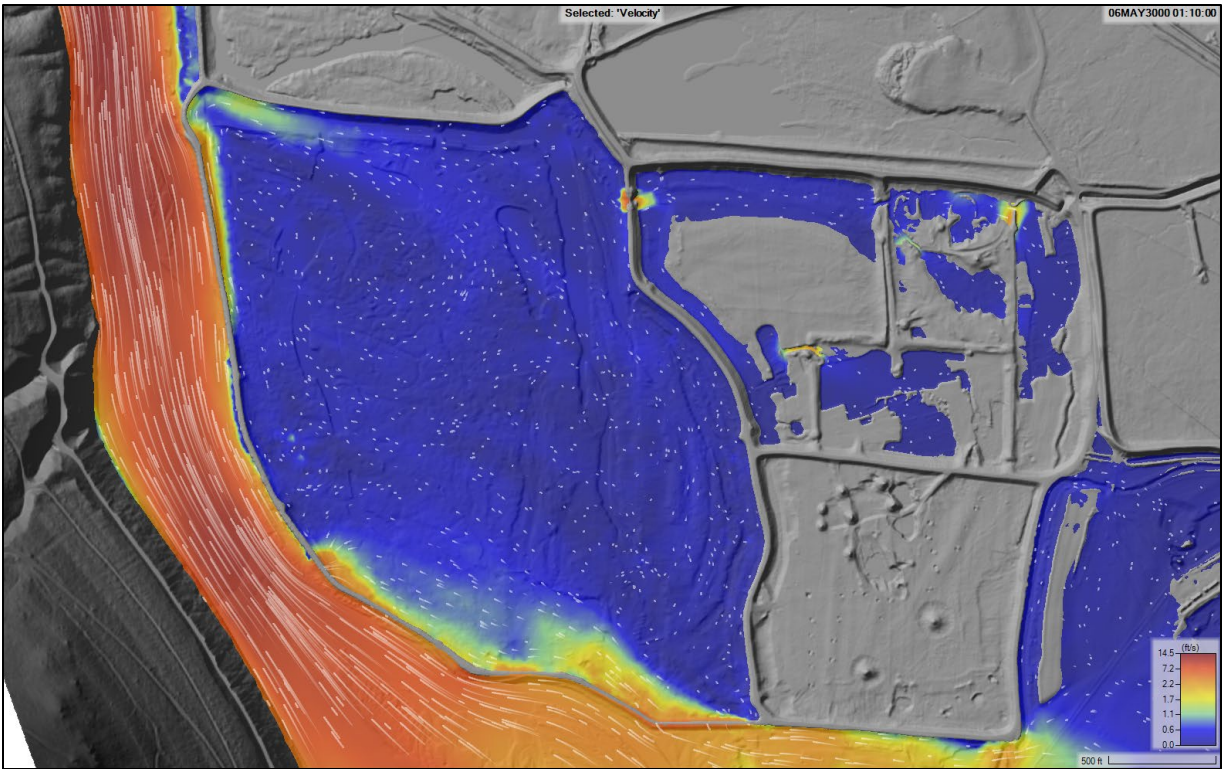
Figure 4-4. Plot of modeled velocities and particle traces for the Scenario 2 mass-wasting failure showing flow across the interior berm into Holding Pond 1.

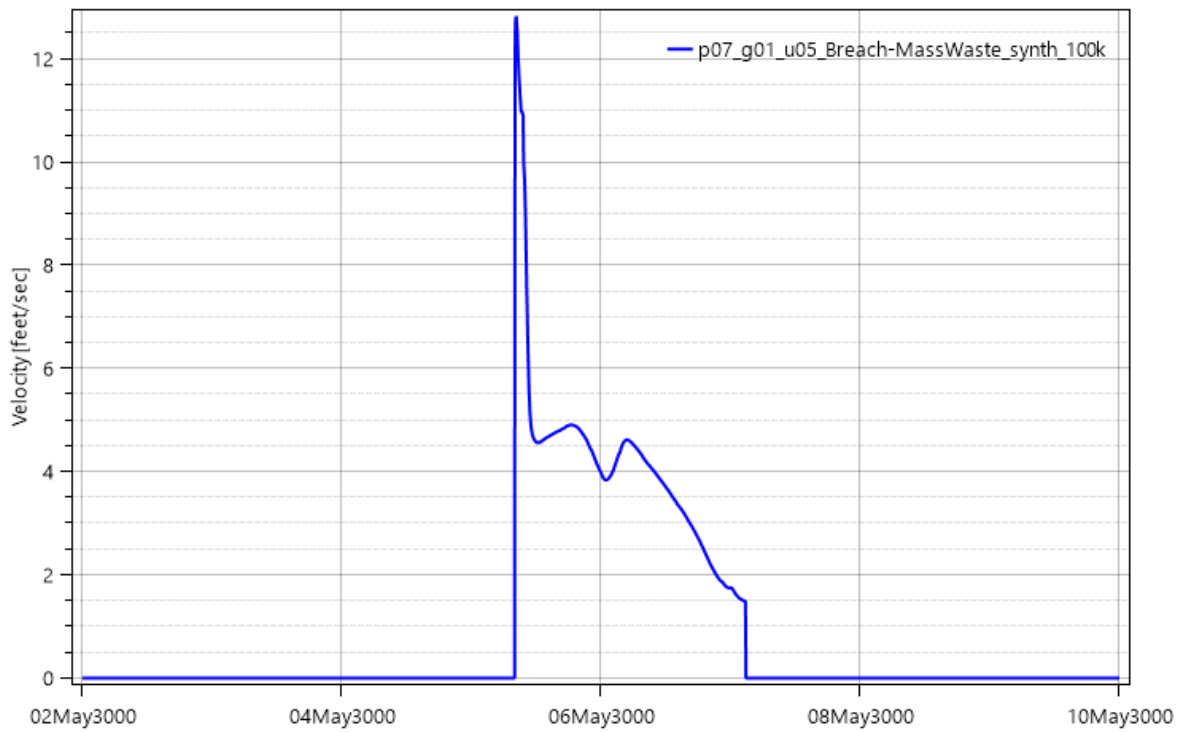
Figure 4-5. Plot of modeled velocity through the breach in the Scenario 2 mass-wasting failure.

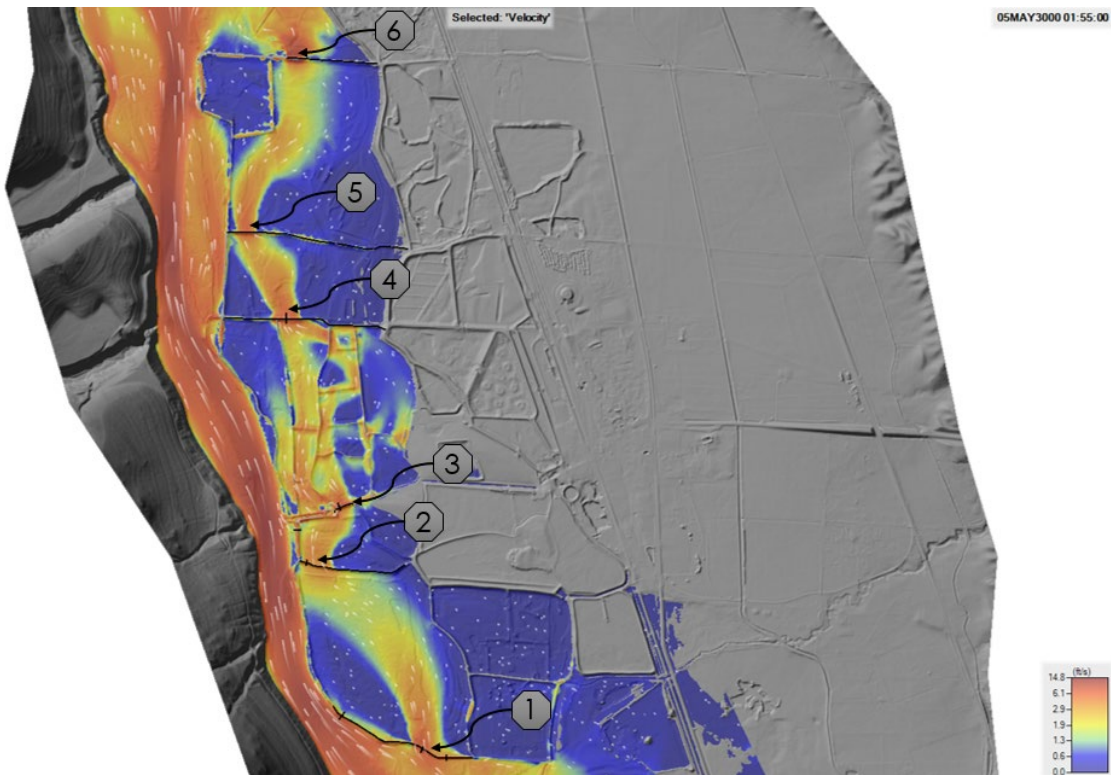
Figure 4-6. Plot of modeled velocities and particle traces at the peak of the Scenario 3 overtopping failure.

Results for Scenario 3, the overtopping failure at the future 0.2% AEP (500-year) flow of ~130,000 cfs, show that an overtopping failure could lead to complete inundation of Holding Ponds 1, 2, 7, 9, 10, 11, 12, 13, 13a, as well as potential for failure of interior berms as shown in Figure 4-6. Flows through the breach approach 200 cfs with maximum velocities through the breach of 5 ft/sec (Figure 4-7). The overtopping failure model output is captured as a video clip (<https://youtu.be/GuAcFnerdTM>).

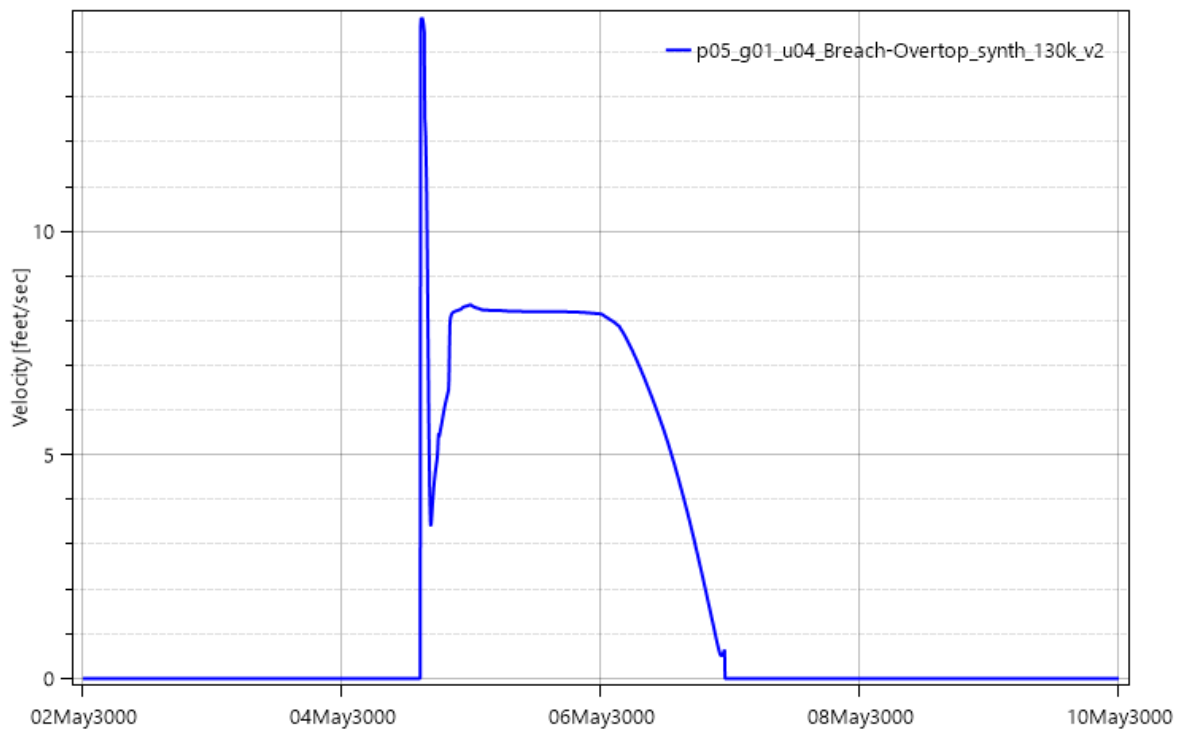
Figure 4-7. Plot of modeled velocity through the breach in the Scenario 3 overtopping failure.

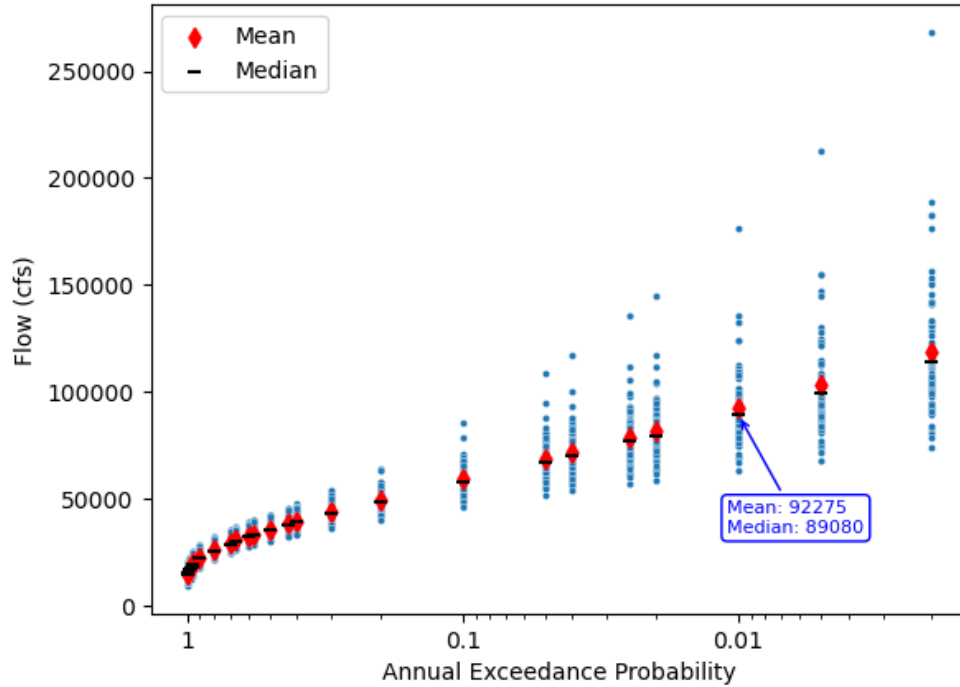
Figure A-1. Distribution of flood frequency quantiles for the CFR downstream of Missoula developed using modeled future flow data assuming a mid-range greenhouse gas scenario (RCP 4.5).

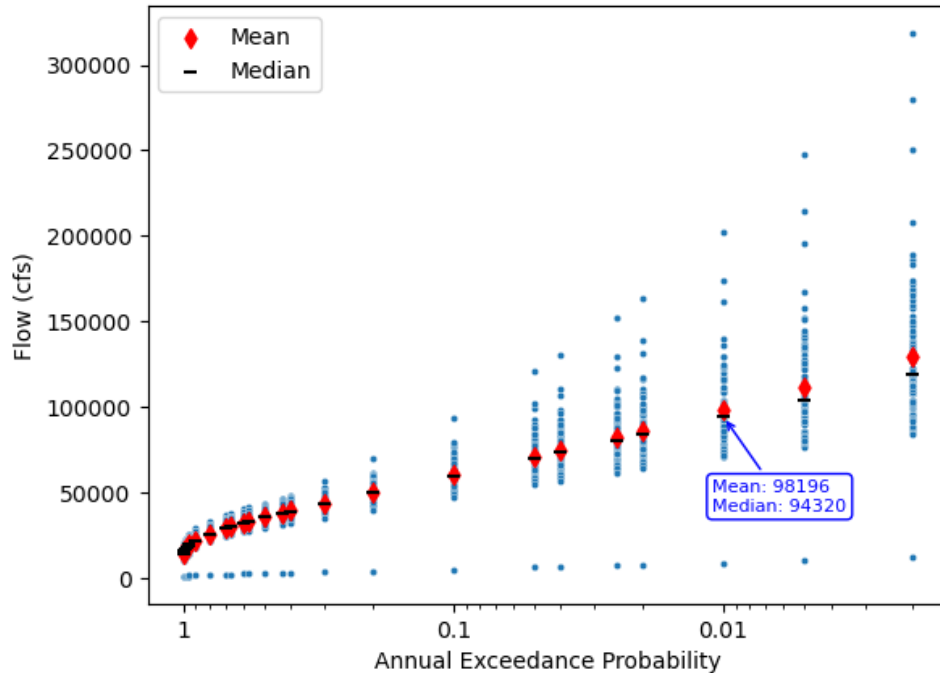
Figure A-2. Distribution of flood frequency quantiles for the CFR downstream of Missoula developed using modeled future flow data assuming a very high greenhouse gas scenario (RCP 8.5).

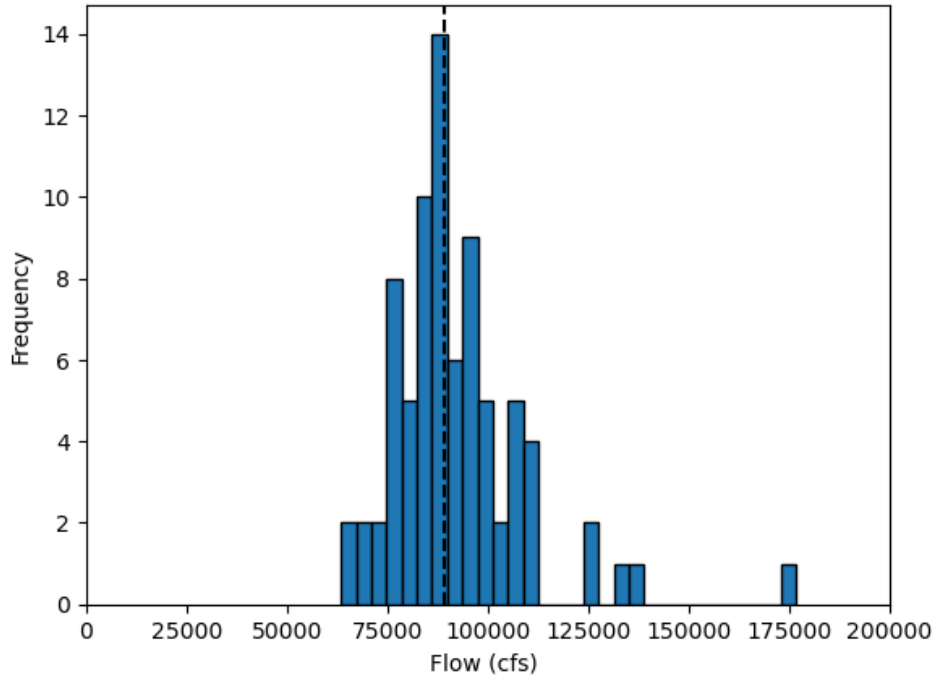
Figure A-3. Histogram of 1% annual chance (100-year) flows for the CFR downstream of Missoula developed using modeled future flow data assuming a mid-range greenhouse gas scenario (RCP 4.5).

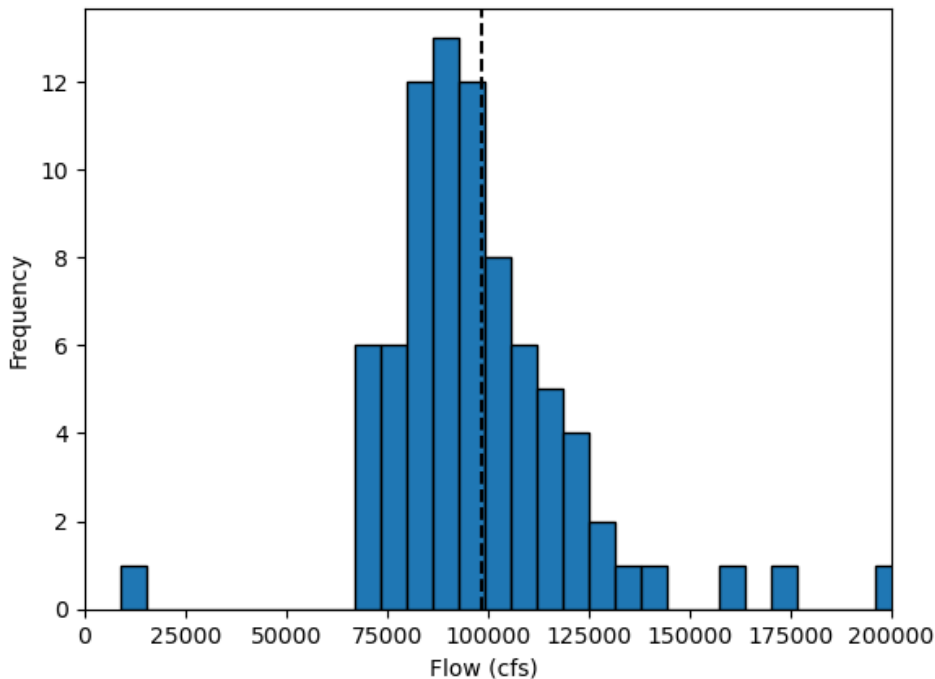
Figure A-4. Histogram of 1% annual chance (100-year) flows for the CFR downstream of Missoula developed using modeled future flow data assuming a very high greenhouse gas scenario (RCP 8.5).

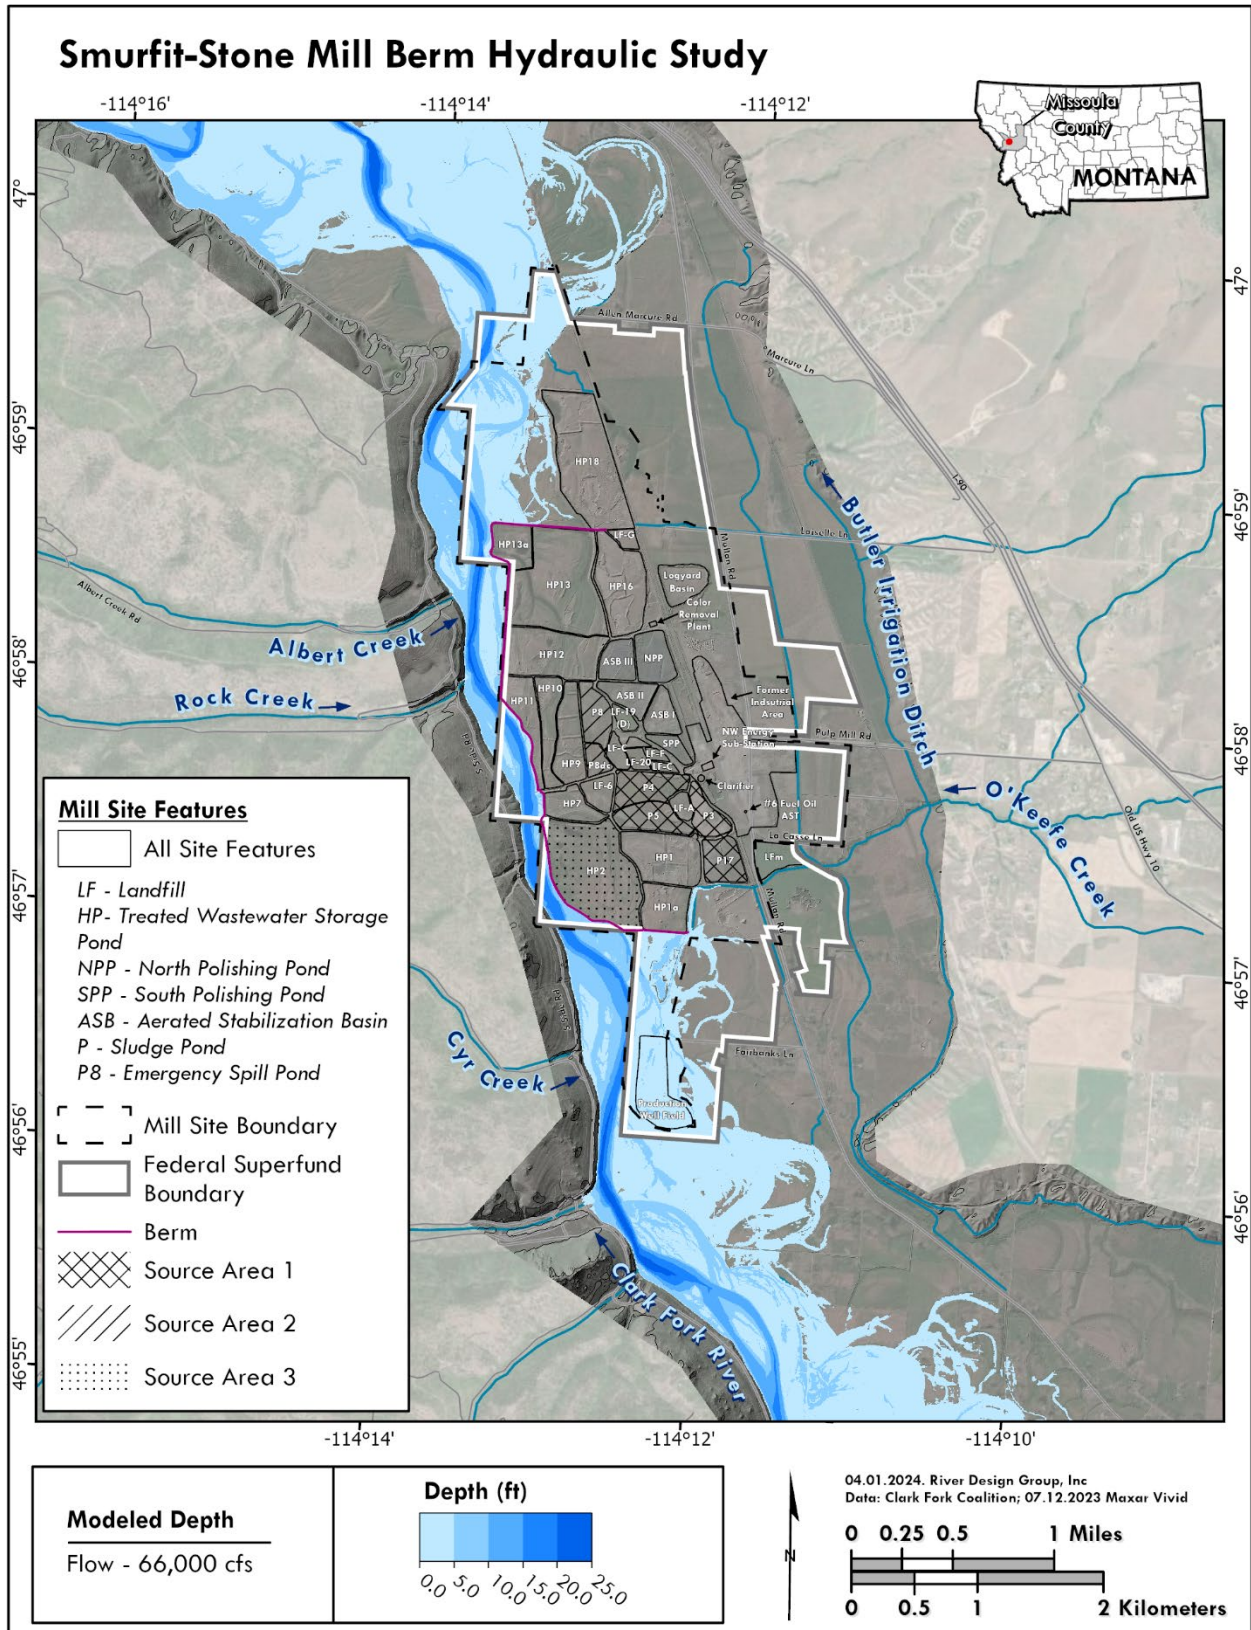
Figure B-1. Depth map for historical 100-year flood event of 66,000 cfs.
