Clark Fork River — Smurfit-Stone Site

Hydraulic Modeling, Flood Mapping and Breach Analysis Report

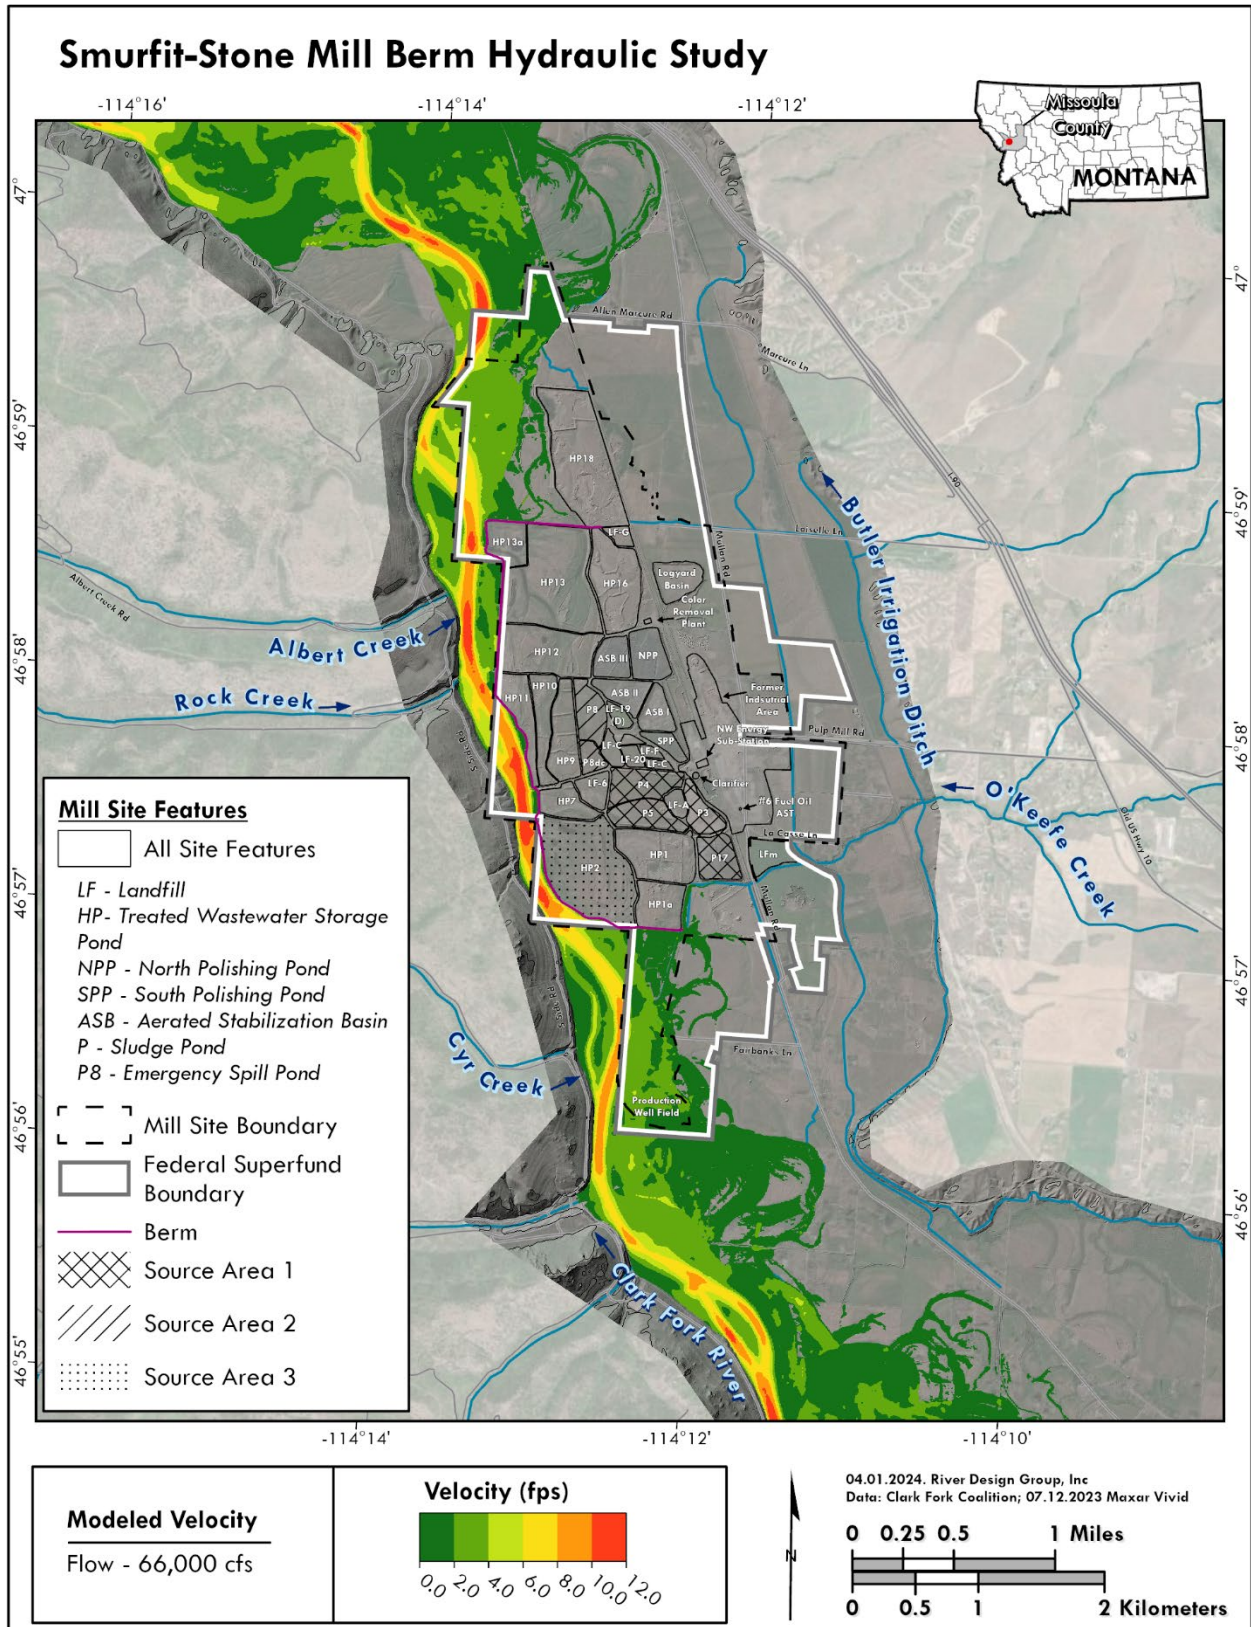
Figure B-2. Velocity map for historical 100-year flood event of 66,000 cfs.

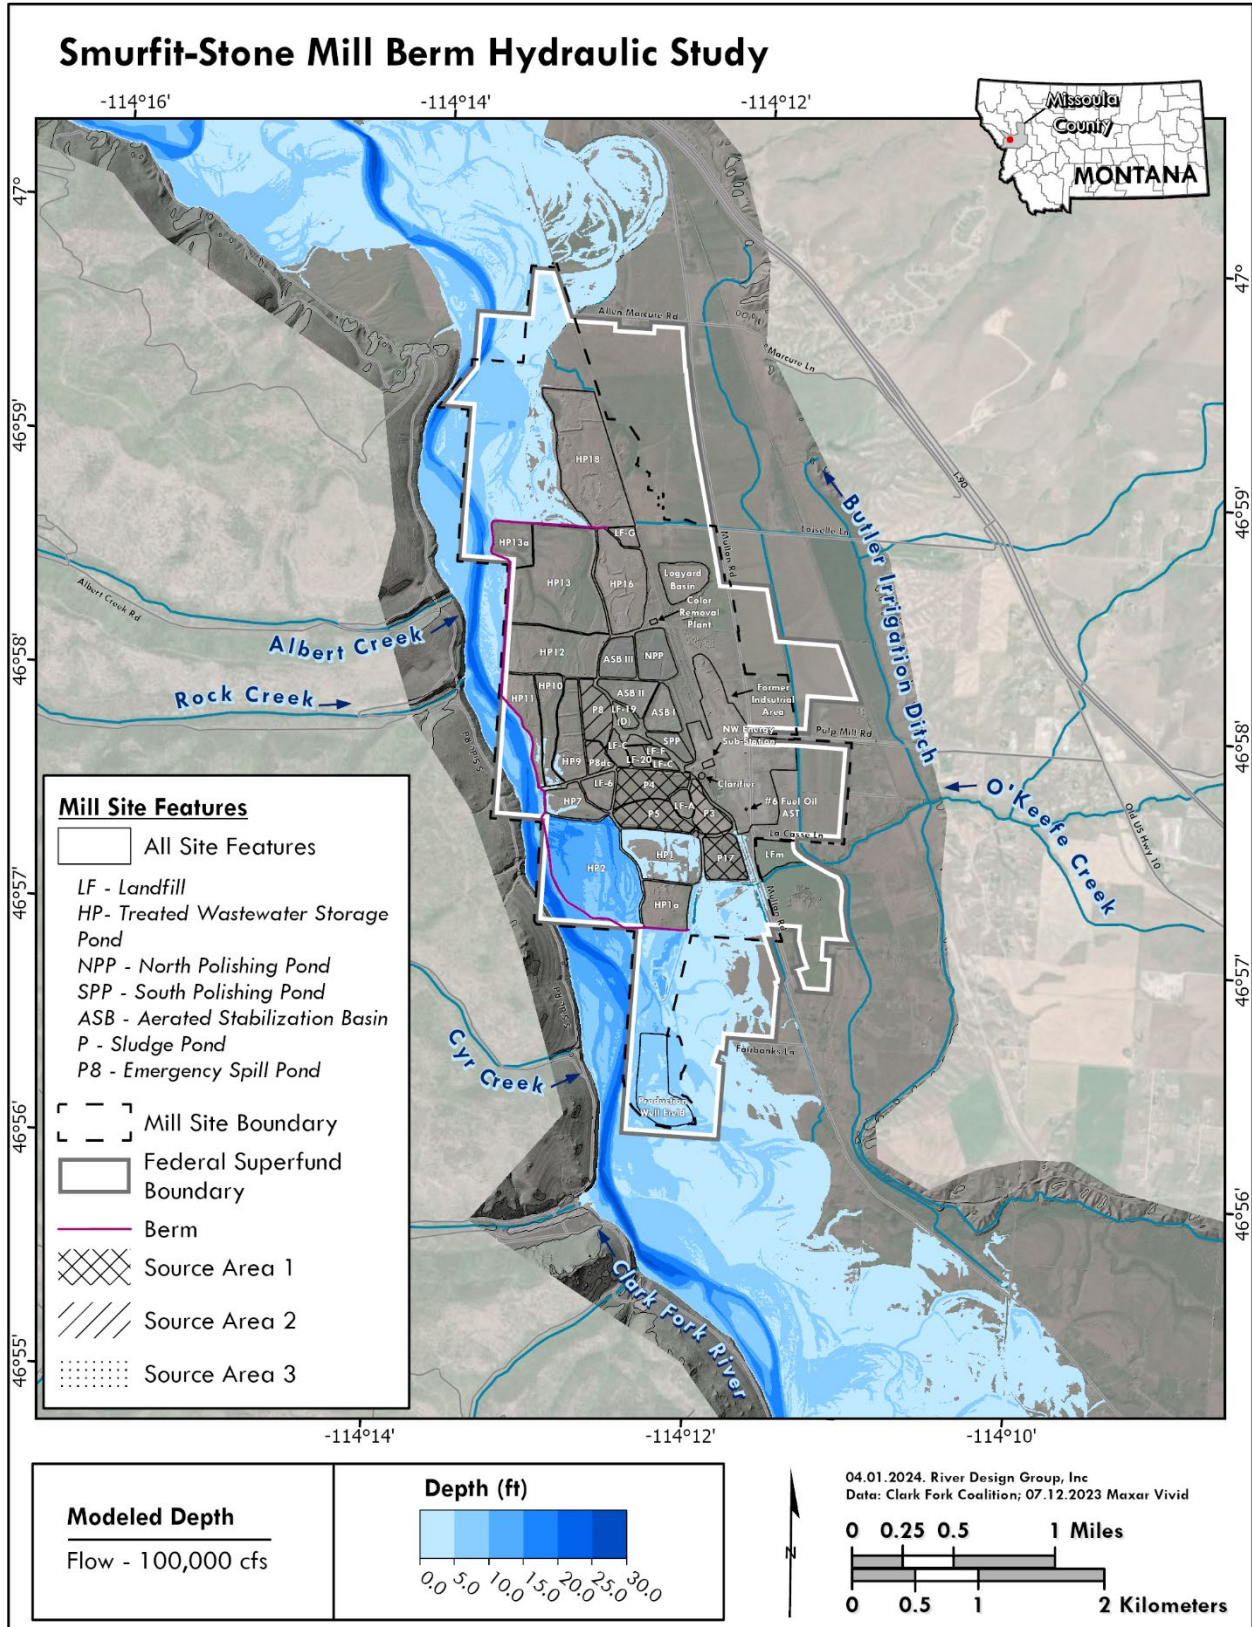
Figure B-3. Depth map for future 100-year flood event of ~100,000 cfs.

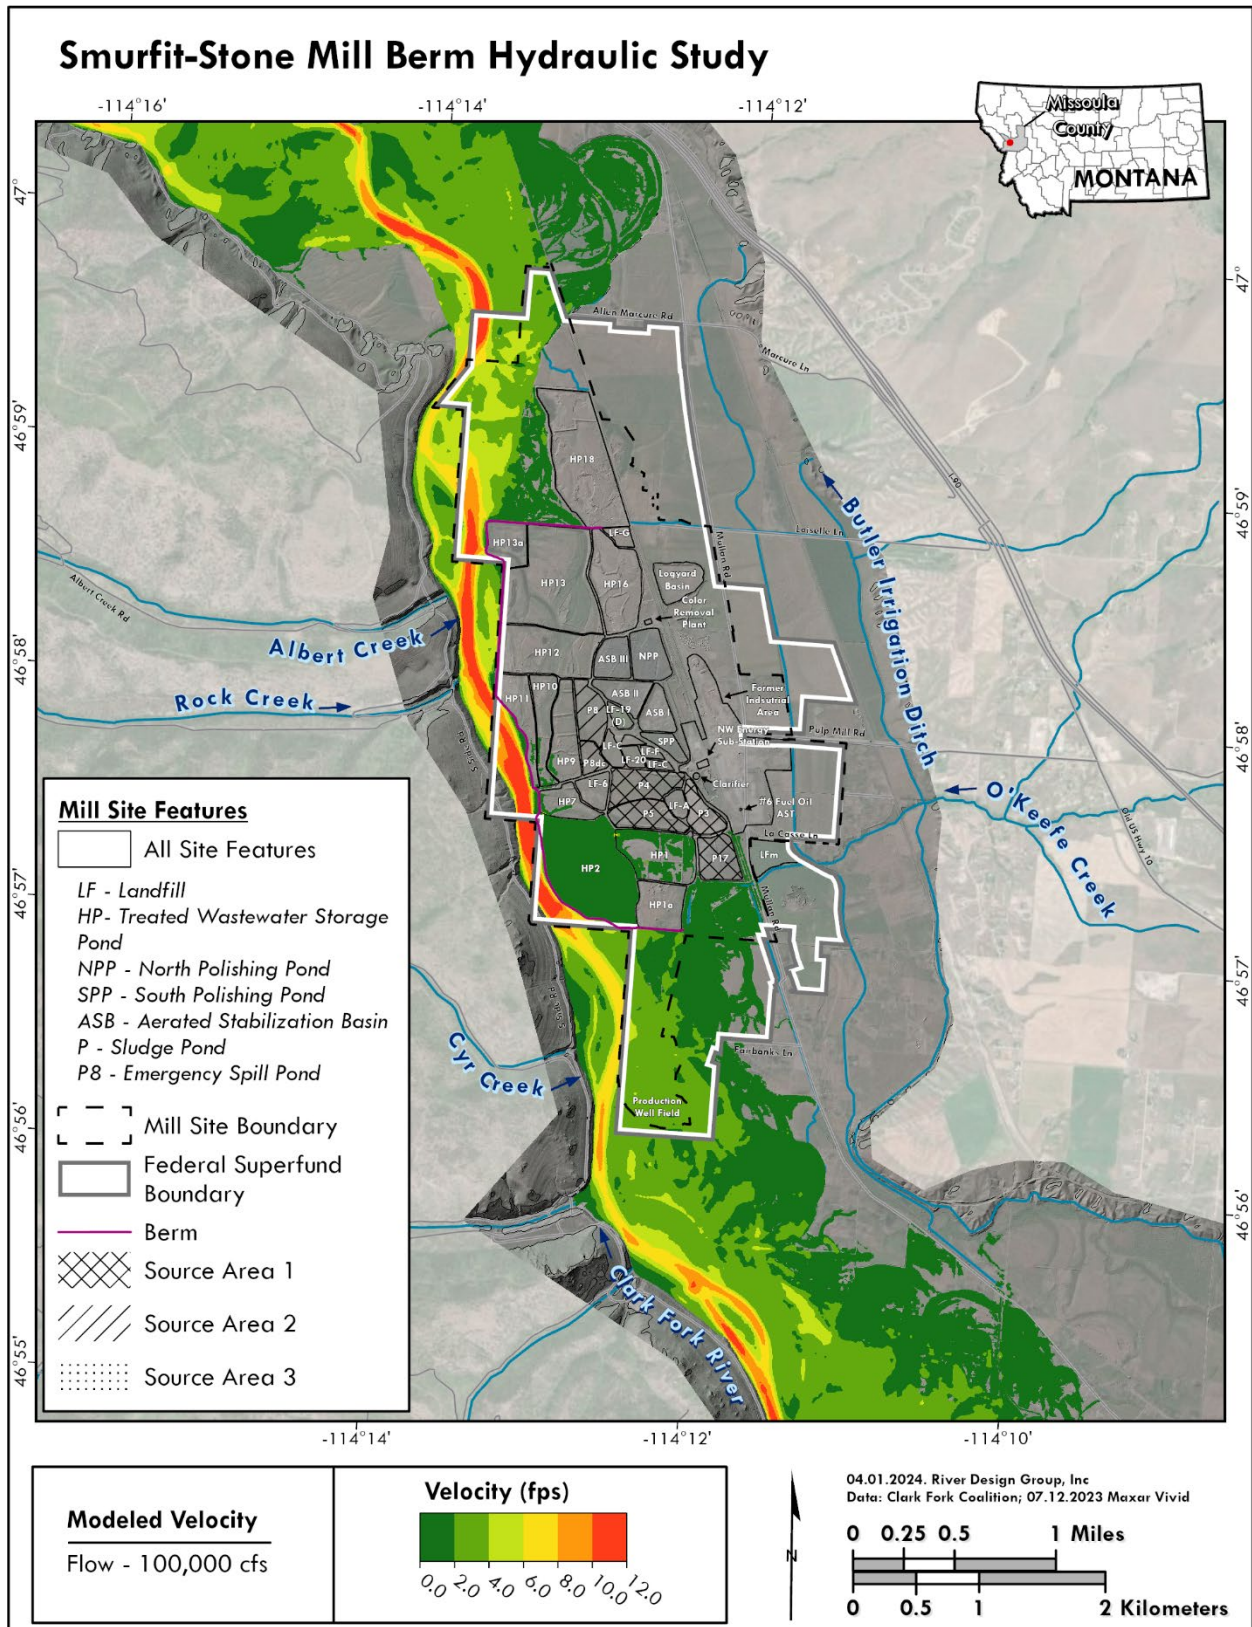
Figure B-4. Velocity map for future 100-year flood event of ~100,000 cfs.

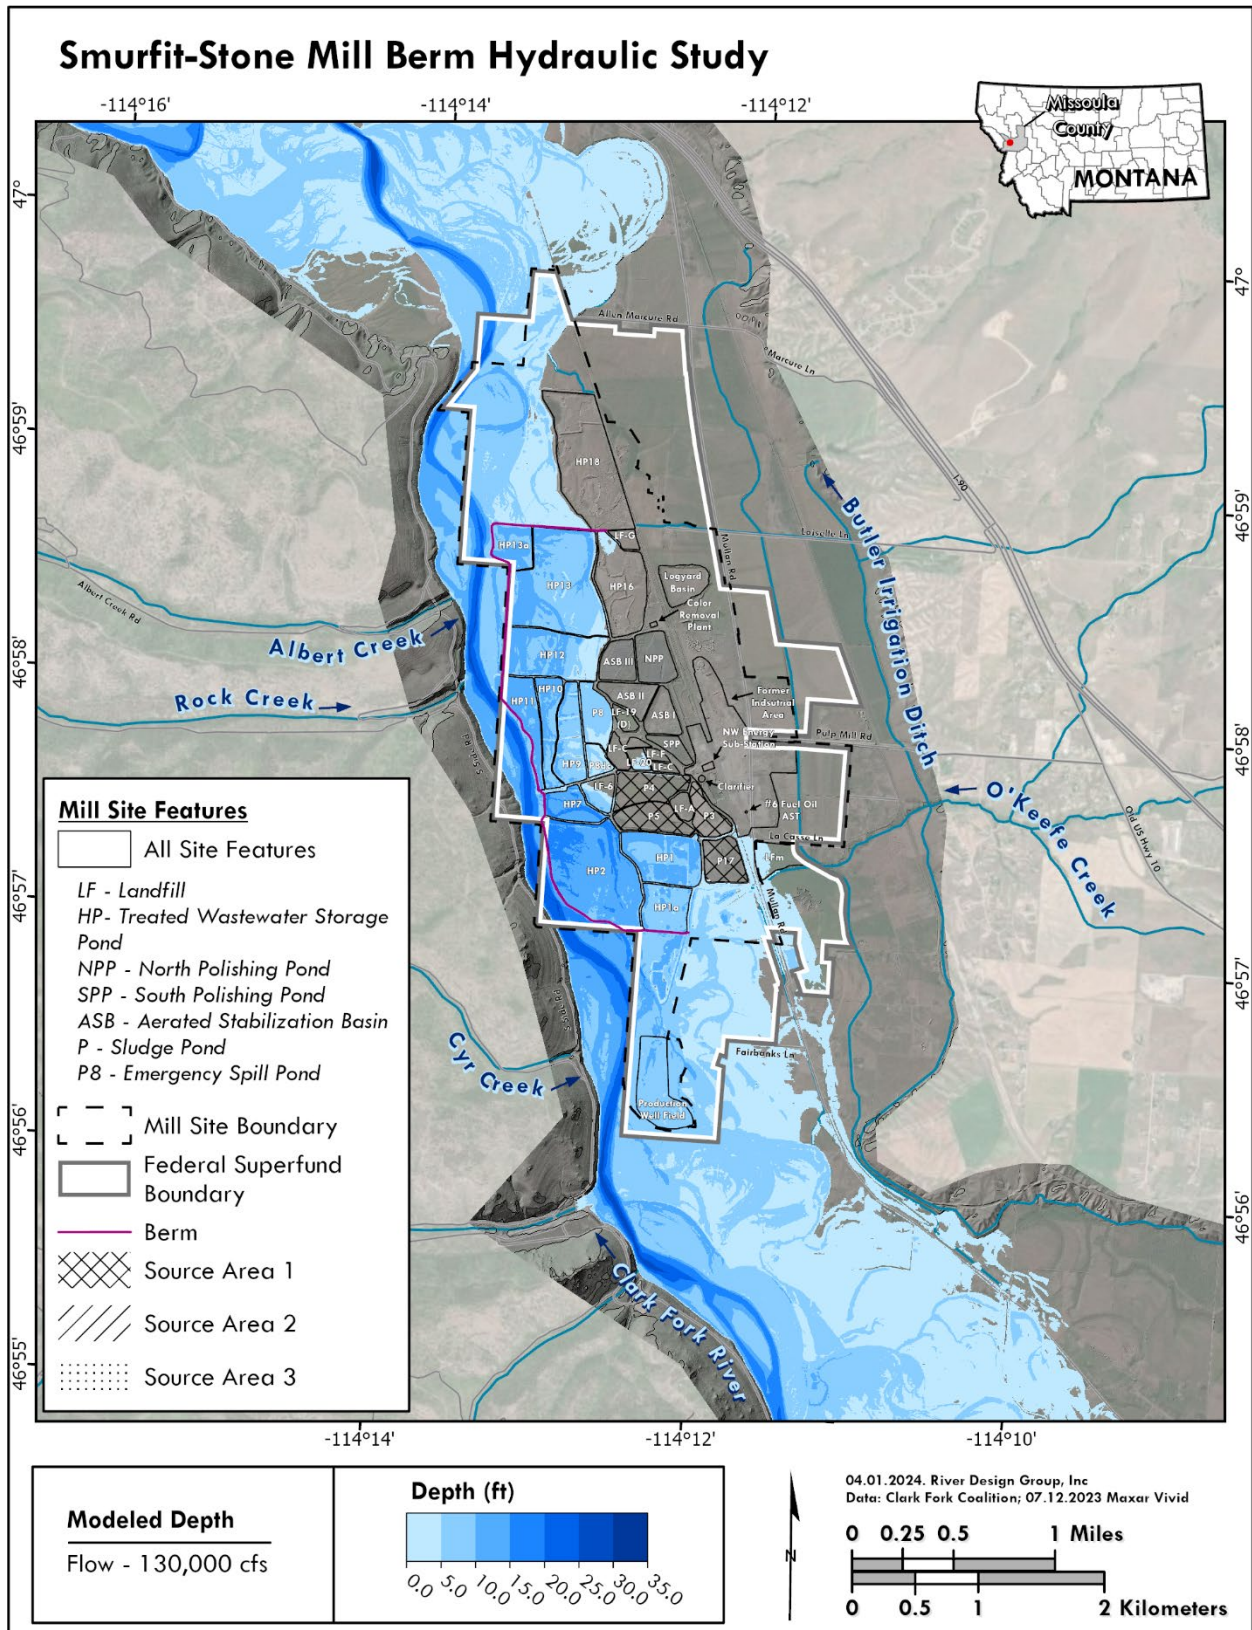
Figure B-5. Depth map for future 500-year flood event of ~130,000 cfs.

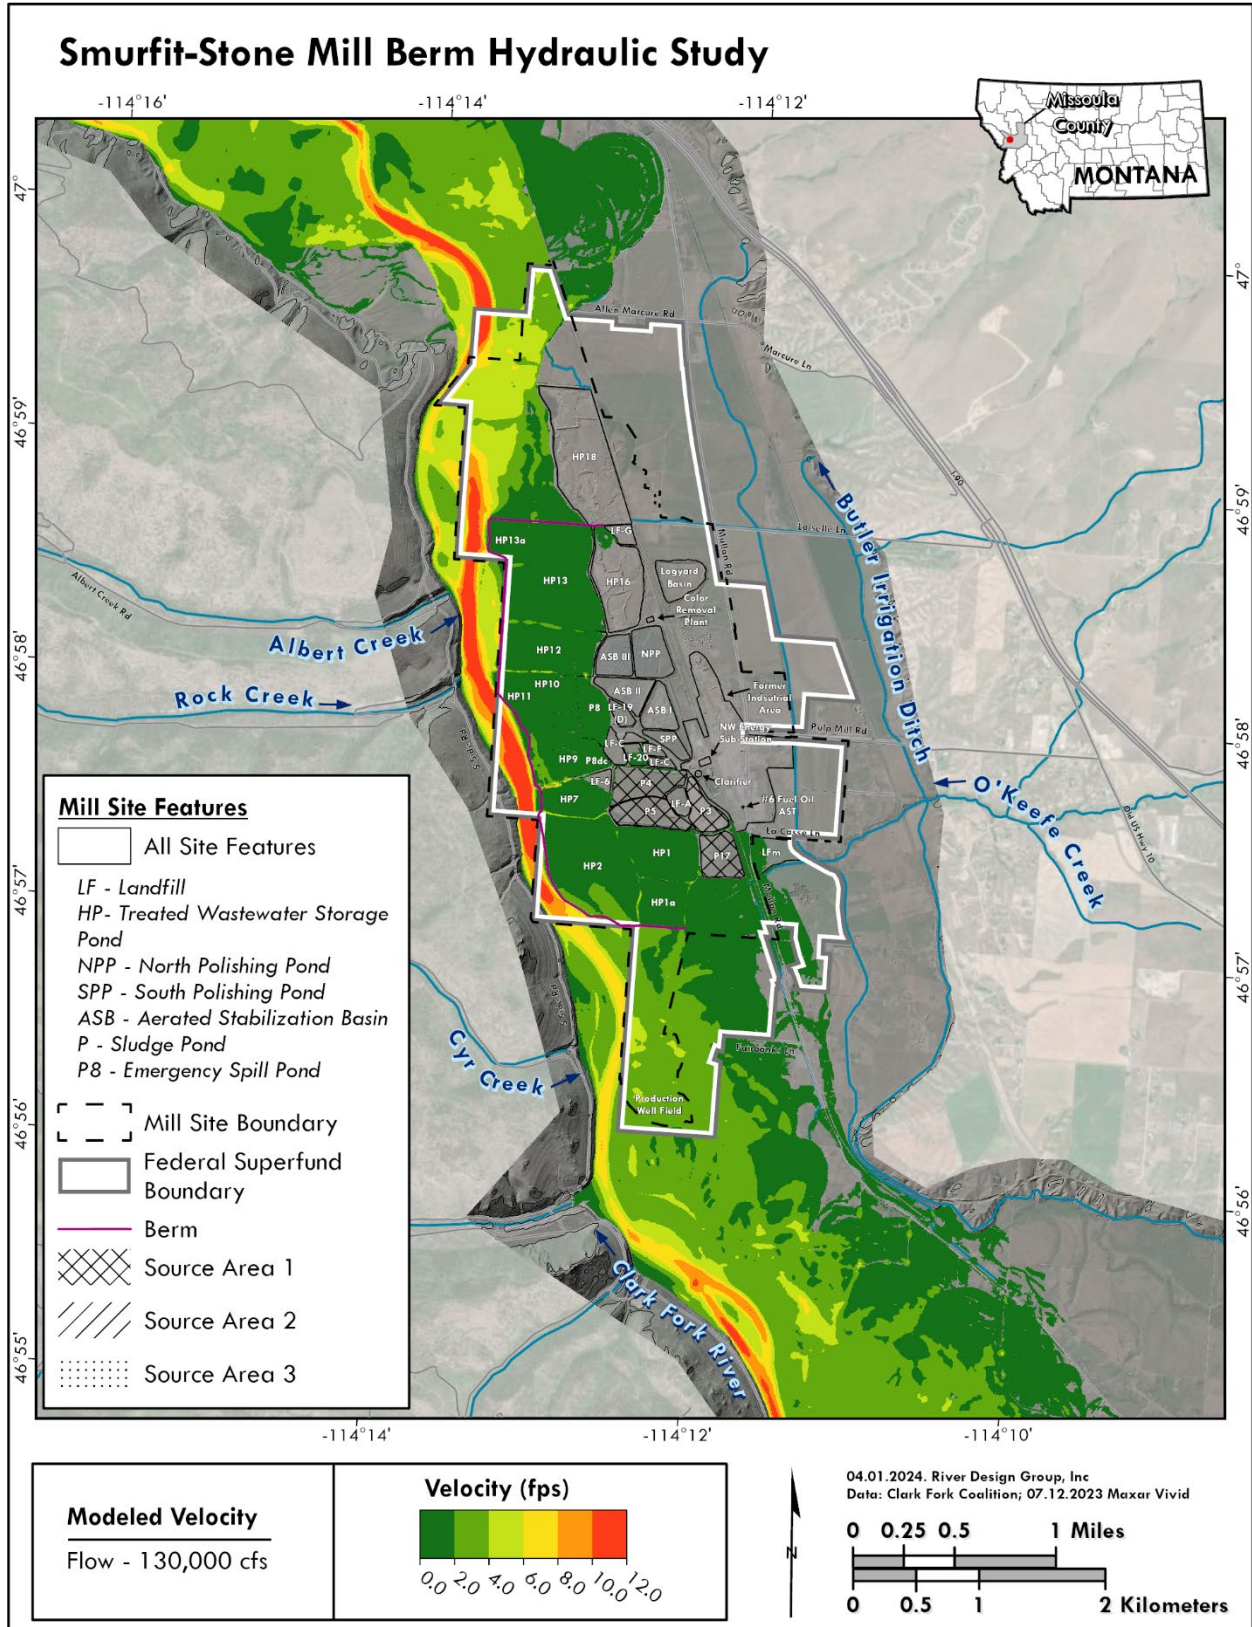
Figure B-6. Velocity map for future 500-year flood event of ~130,000 cfs.

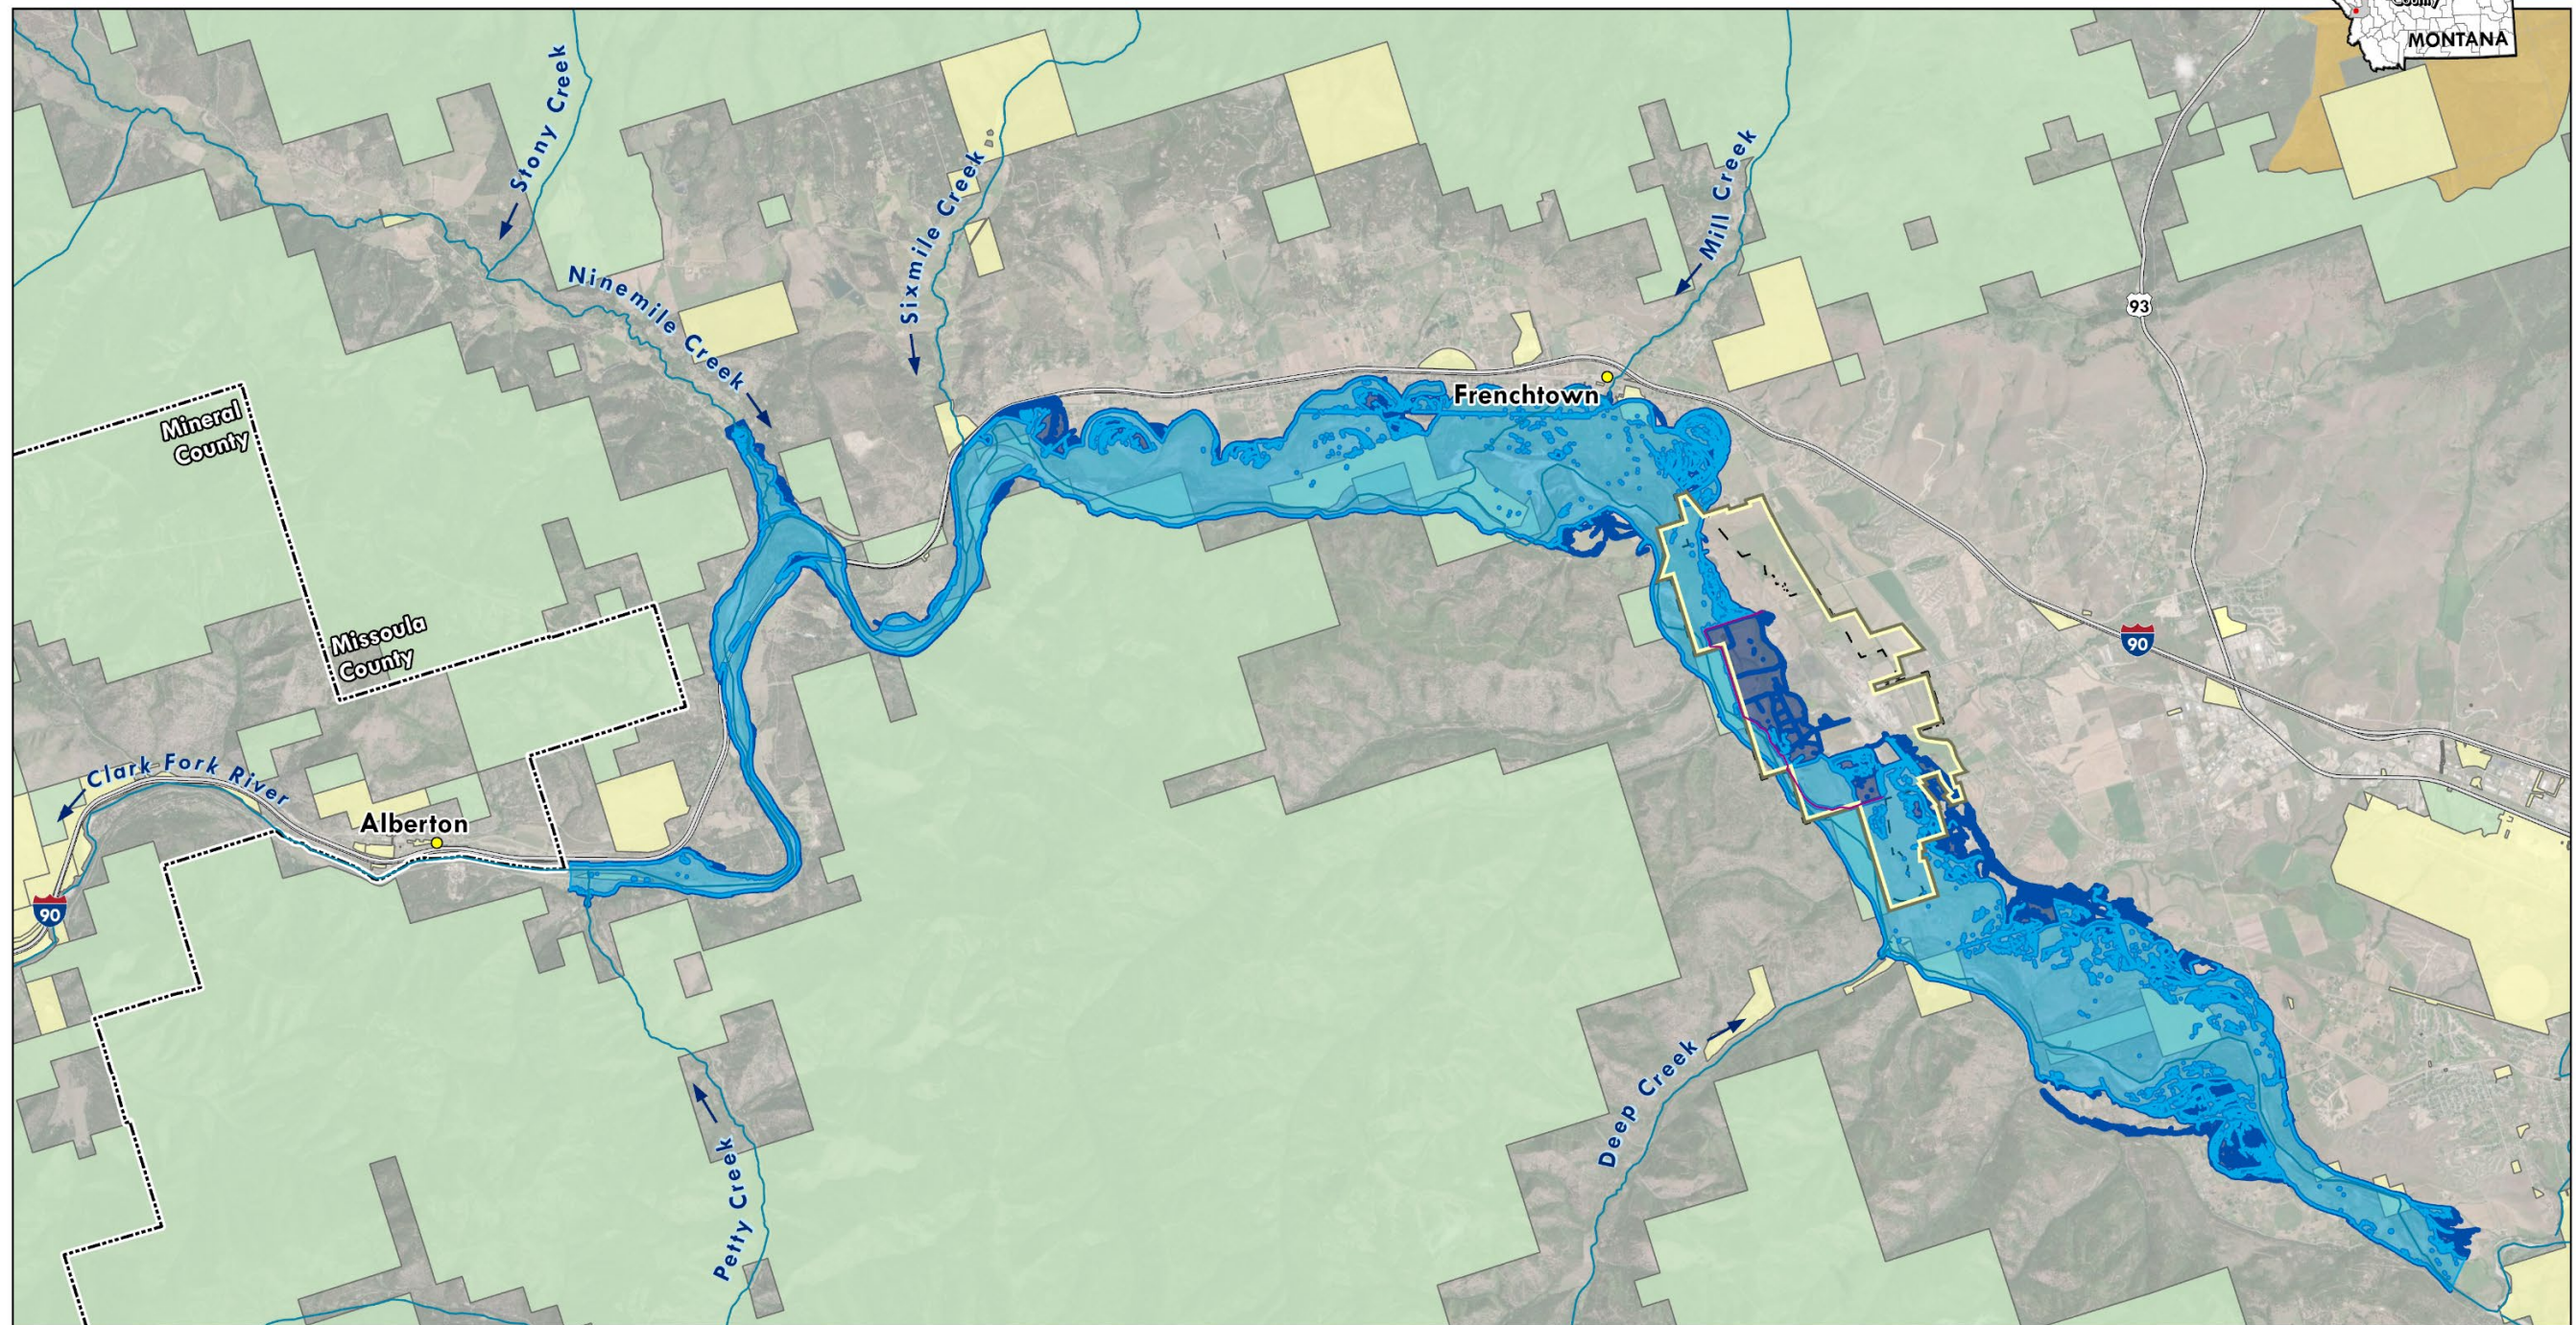
Smurfit-Stone Mill Berm Hydraulic Study – Potential Released Contaminant Deposition Areas

Figure C-1. Potential released contaminant deposition area map.

It is assumed that contaminated materials released from the Site due to failure of the berm(s) would result in widespread dispersal downstream of the Site. Given the fine-grained nature of materials in the holding ponds and waste dumps, it is likely that contaminants would be well mixed in the water leaving the site. The contaminants would likely be dispersed across the floodplain downstream of the Site and deposited in low-velocity areas such as Frenchtown Slough. Contaminants that entered the main flow of the river would likely be transported further downstream, through Alberton Gorge and possibly as far as Thompson Falls Reservoir or Lake Pend Oreille. A map showing potential deposition areas is included in Appendix C.

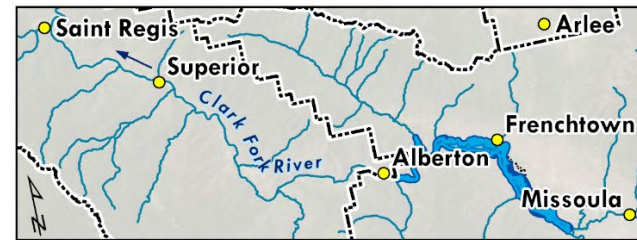
Smurfit-Stone Mill Site Features	Inundation Extent	Ownership
Mill Site Boundary	130,000 cfs	US Forest Service
Federal Superfund Boundary	100,000 cfs	State of Montana
Berm		Flathead Indian Reservation
